Pit or Below-Grade Tank Registration or Closure

Operator: Dugan Production Corp Telephone: (505)325-1821 e-mail address:
Address: P.O. Box 420, Farmington, New Mexico 87401
Facility or well name: Mary Anne #3 API #: 30-045-25050 U/L or Qtr/Qtr L Sec 9 T 24N R 9W
County: San Juan Latitude 36.32614 Longitude 107.80022 NAD: 1927 ☐ 1983 ☐ Surface Owner Federal ☒ State ☐ Private ☐ Indian ☐

FIELD REPORT: PIT CLOSURE VERIFICATION

LOCATION: NAME: MARY ANNE WELL #: 3 TYPE: SEP
QUAD/UNIT: L9 SEC: 24N TWP: 9W RNG: PM: NM CNTY: SJ ST: NM
QTR/FOOTAGE: 790 FWL x 1650 FSL CONTRACTOR: DPC

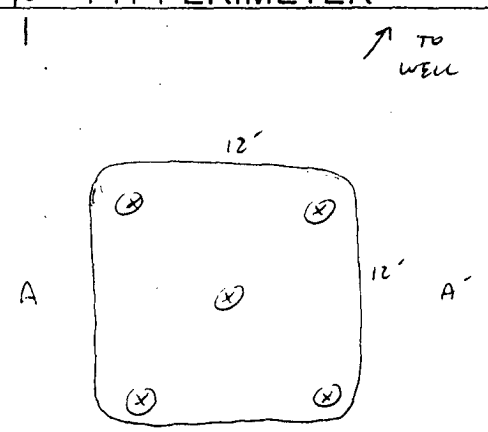
PIT PERIMETER

FIELD NOTES & REMARKS: PIT LOCATED APPROXIMATELY 69 FT. S 34W FROM WELLHEAD.

SAMPLE ID	FIELD HEADSPACE (ppm)
1 @	
2 @	
3 @	
4 @	
5 @	
5-POINT	36
COMPOSITE @ 8'

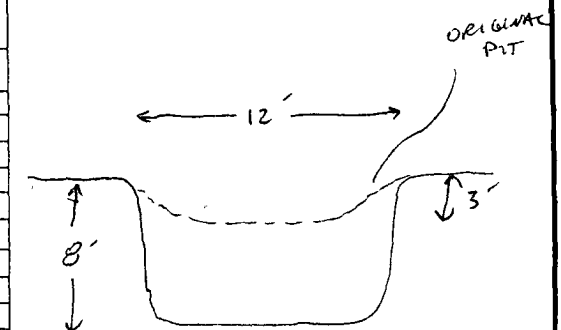
PIT PROFILE

EXCAVATION APPROX. 12 FT. x 12 FT. x 8 FT. DEEP. CUBIC YARDAGE: 27 ±

SOIL TYPE: SAND / (SILTY SAND) / SILT / SILTY CLAY / CLAY / GRAVEL / OTHER
SOIL COLOR: Lite TAN
COHESION (ALL OTHERS): (NON COHESIVE) / SLIGHTLY COHESIVE / COHESIVE / HIGHLY COHESIVE
CONSISTENCY (NON COHESIVE SOILS) (LOOSE) / FIRM / DENSE / VERY DENSE
PLASTICITY (CLAYS): NON PLASTIC / SLIGHTLY PLASTIC / COHESIVE / MEDIUM PLASTIC / HIGHLY PLASTIC
DENSITY (COHESIVE CLAYS & SILTS): SOFT / FIRM / STIFF / VERY STIFF / HARD
MOISTURE: DRY / (SLIGHTLY MOIST) / MOIST / WET / SATURATED / SUPER SATURATED
DISCOLORATION/STAINING OBSERVED: (YES) NO EXPLANATION - IN Removed Soils
HC ODOR DETECTED: (YES) NO EXPLANATION - IN Removed soils
SAMPLE TYPE: GRAB / (COMPOSITE) - # OF PTS. 5
ADDITIONAL COMMENTS: 12 x 12 x 3' Deep Unlined Pit. Use Backhoe to Dig Pit to Clean Soils
