Pit or Below-Grade Tank Registration or Closure

Operator: Dugan Production Corp Telephone: (505)325-1821 e-mail address:
Address: P.O. Box 420, Farmington, New Mexico 87401
Facility or well name: Muddy Mudda #1 API #: 30-045-25919 U/L or Qtr/Qtr D Sec 21 T 24N R 9W
County: San Juan Latitude 36.30465 Longitude 107.79998 NAD: 1927 ☐ 1983 ☐ Surface Owner Federal ☒ State ☐ Private ☐ Indian ☐

FIELD REPORT: PIT CLOSURE VERIFICATION

LOCATION: NAME: MUDDY MUDDA WELL #: 1 TYPE: SEP
QUAD/UNIT: D SEC: 21 TWP: 24N RNG: 9W PM: NM CNTY: SJ ST: NM
QTR/FOOTAGE: 790 FNL x 1040 FWL CONTRACTOR: DPC

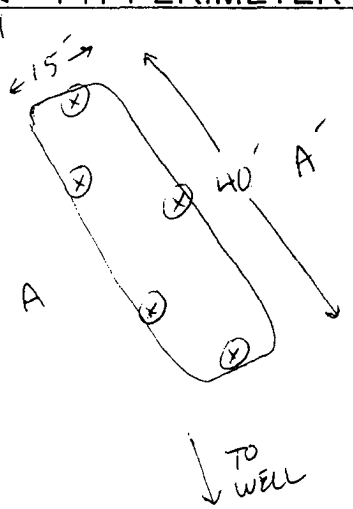
PIT PERIMETER

FIELD NOTES & REMARKS: PIT LOCATED APPROXIMATELY 90 FT. N25W FROM WELLHEAD.

SOIL TYPE: SAND / (SILTY SAND) / SILT / SILTY CLAY / CLAY / GRAVEL / OTHER
SOIL COLOR: DARK TAN
COHESION (ALL OTHERS): NON COHESIVE / (SLIGHTLY COHESIVE) / COHESIVE / HIGHLY COHESIVE
CONSISTENCY (NON COHESIVE SOILS): LOOSE / (FIRM) / DENSE / VERY DENSE
PLASTICITY (CLAYS): NON PLASTIC / SLIGHTLY PLASTIC / COHESIVE / MEDIUM PLASTIC / HIGHLY PLASTIC
DENSITY (COHESIVE CLAYS & SILTS): SOFT / FIRM / STIFF / VERY STIFF / HARD
MOISTURE: DRY / (SLIGHTLY MOIST) / MOIST / WET / SATURATED / SUPER SATURATED
DISCOLORATION/STAINING OBSERVED: (YES) NO EXPLANATION - IN REMOVED SOILS
HC ODOR DETECTED: (YES) NO EXPLANATION - IN REMOVED SOILS
SAMPLE TYPE: GRAB / COMPOSITE - # OF PTS.
ADDITIONAL COMMENTS: 40' x 15' x 3' Deep Unlined Pit.
USE BACKHOE TO Remove Impacted Soils to 8' B.G.

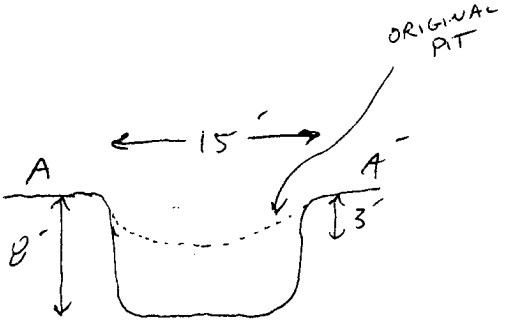
PIT PROFILE

EXCAVATION APPROX. 40 FT. x 15 FT. x 8 FT. DEEP. CUBIC YARDAGE: 110 ±
