Pit or Below-Grade Tank Registration or Closure

Operator: Burlington Resources Telephone: (505) 326-9841 e-mail address: LHasely@br-inc.com
Address: 3401 East 30th Street, Farmington, New Mexico, 87402
Facility or well name: San Juan 28-6 Unit NP 420 API #: 30039249920000 U/L or Qtr/Qtr A Sec 32 T 28N R 6W
County: Rio Arriba Latitude N36d 37.358' Longitude W107d 29.094' NAD: 1927 ☒ 1983 ☐
Surface Owner: Federal ☒ State ☐ Private ☐ Indian ☐

FIELD REPORT: CLOSURE VERIFICATION

LOCATION: NAME: San Juan 28-6 WELL #: NP 420 PIT:
QUAD/UNIT: A SEC: 32 TWP: 28N RNG: 6W PM: NMPM CNTY: Rio Arriba ST: NM
QTR/FOOTAGE: 940' FNL 1160' FEL CONTRACTOR: L&R

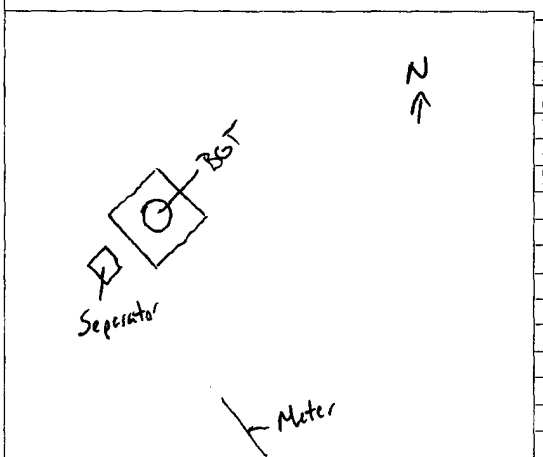
PIT PERIMETER

FIELD NOTES & REMARKS: PIT LOCATED APPROXIMATELY 88' FT. 25° FROM WELLHEAD.
DEPTH TO GROUNDWATER: 0 NEAREST WATER SOURCE: 0 NEAREST SURFACE WATER: 10
NMOCD RANKING SCORE: 10 NMOCD TPH CLOSURE STD: 1000 PPM

No visible staining present. Hard sandstone right below fiberglass BGT.
No soil removed from site
