Pit, Below-Grade Tank, or Proposed Alternative Method Permit or Closure Plan Application

Operator: ConocoPhillips Company OGRID #: 217817
Address: PO BOX 4289, Farmington, NM 87499
Facility or well name: SAN JUAN 28-7 UNIT 29 – NORTH TANK
API Number: 30-039-07459 OCD Permit Number: _____
U/L or Qtr/Qtr L Section 7 Township 28N Range 7W County: Rio Arriba
Center of Proposed Design: Latitude 36.67233 °N Longitude -107.61965 °W NAD: ☐1927 ☒ 1983
Surface Owner: ☒ Federal ☐ State ☐ Private ☐ Tribal Trust or Indian Allotment

ConocoPhillips Company
San Juan Basin
Below Grade Tank Closure Report

Lease Name: San Juan 28-7 Unit 29 – North Tank
API No.: 30-039-07459

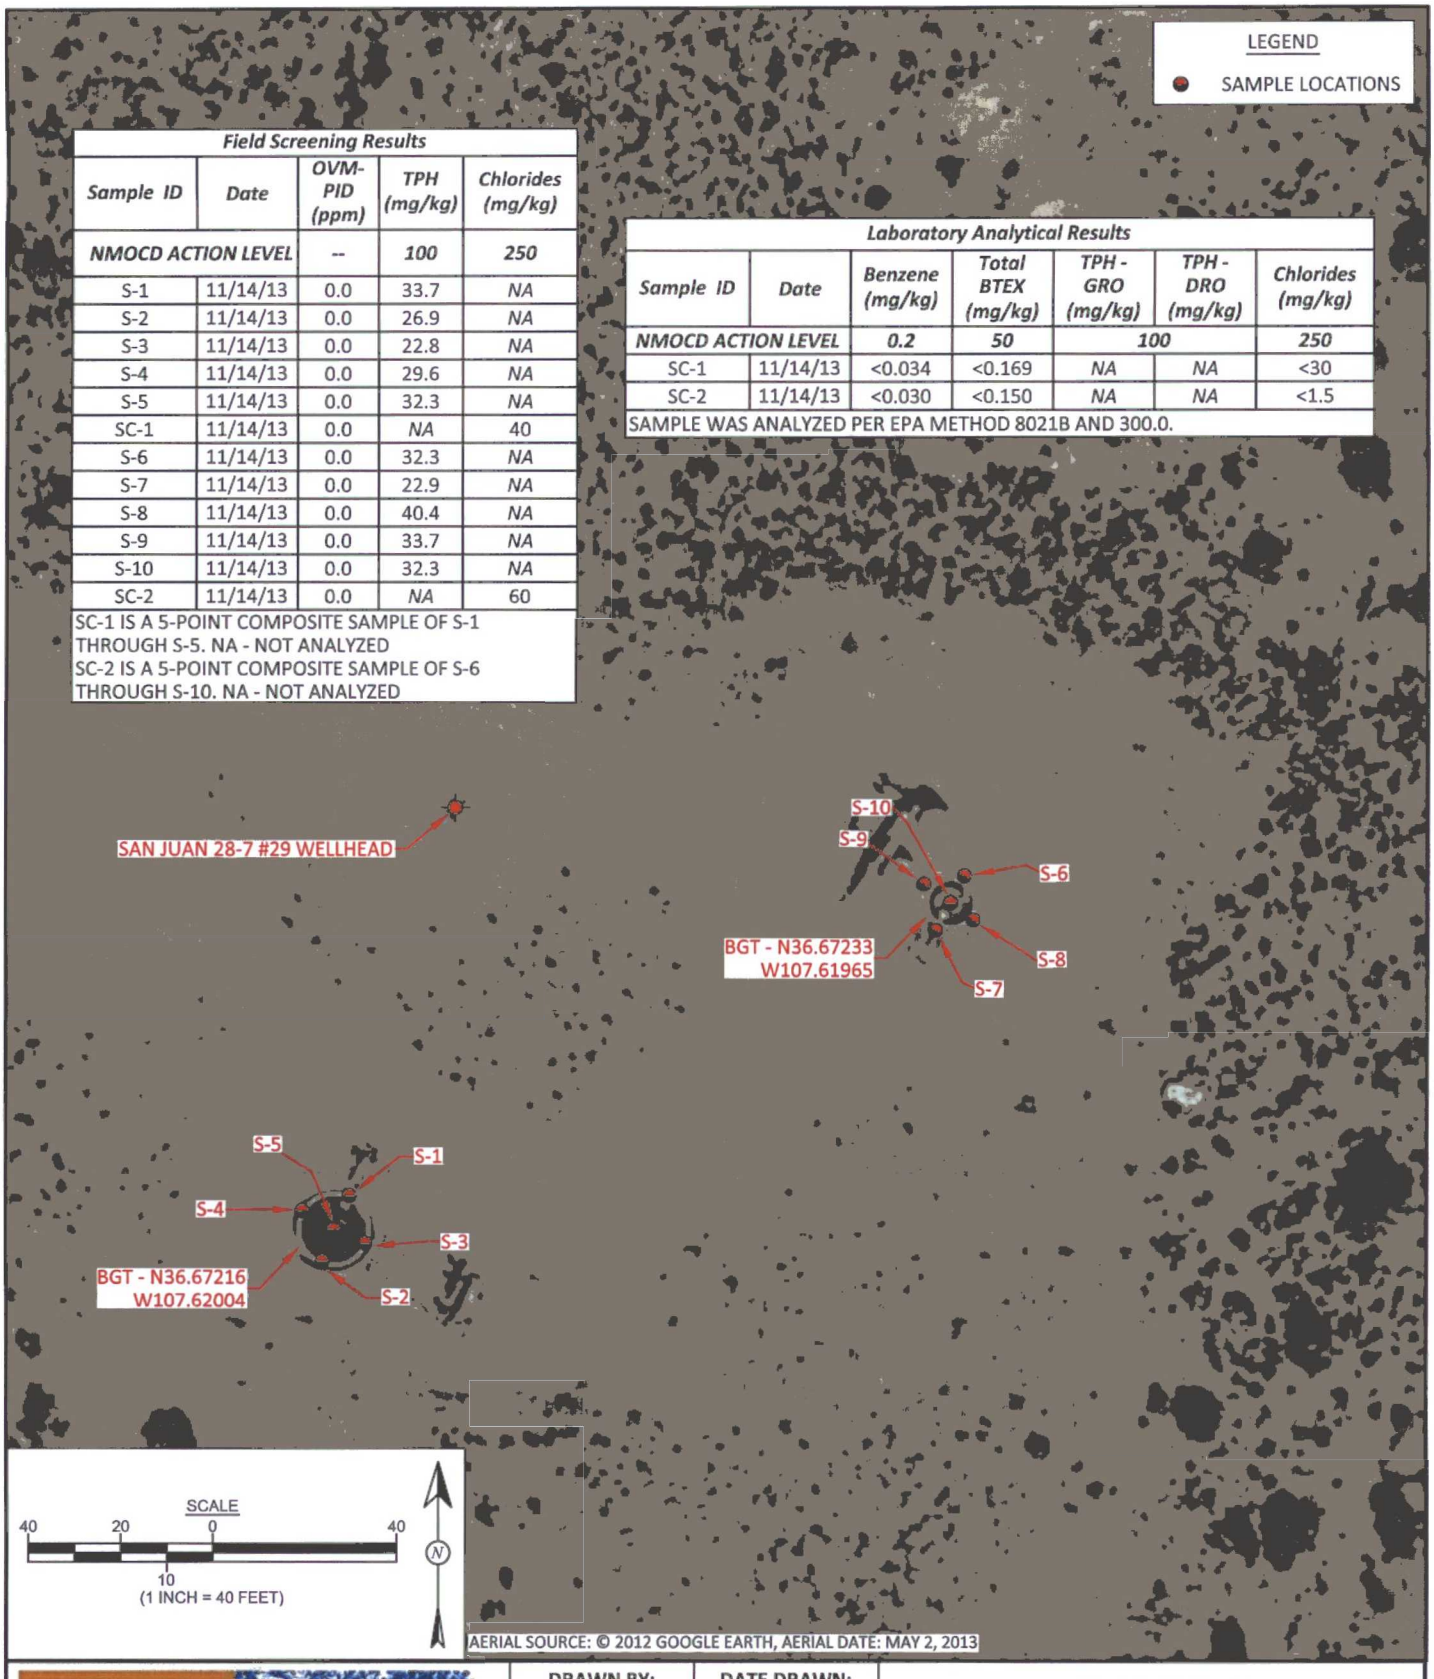
Field Screening Results

Sample ID	Date	OVM-PID (ppm)	TPH (mg/kg)	Chlorides (mg/kg)
NMOCD ACTION LEVEL		--	100	250
S-1	11/14/13	0.0	33.7	NA
S-2	11/14/13	0.0	26.9	NA
S-3	11/14/13	0.0	22.8	NA
S-4	11/14/13	0.0	29.6	NA
S-5	11/14/13	0.0	32.3	NA
SC-1	11/14/13	0.0	NA	40
S-6	11/14/13	0.0	32.3	NA
S-7	11/14/13	0.0	22.9	NA
S-8	11/14/13	0.0	40.4	NA
S-9	11/14/13	0.0	33.7	NA
S-10	11/14/13	0.0	32.3	NA
SC-2	11/14/13	0.0	NA	60
