Pit, Below-Grade Tank, or Proposed Alternative Method Permit or Closure Plan Application

Hilcorp Energy Company
San Juan Basin: New Mexico Assets
Below Grade Tank Closure Report

Lease Name: San Juan 32-8 Unit 230 POD 1
API No.: 30-045-27970

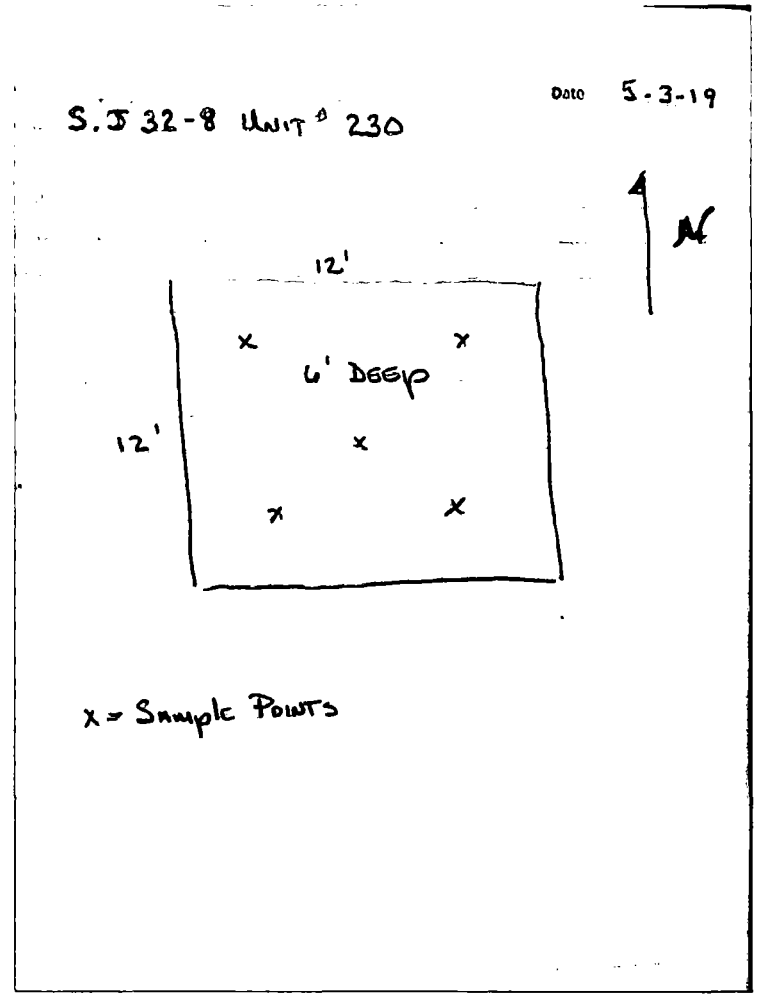
Composite Sample Location

- Confirmation sampling occurred on 11/18/2018 and was submitted for closure but the wrong site characterization was used and results were over on TPH
- Confirmation sampling was scheduled for 4/30/19 but due to weather was rescheduled and occurred on 5/3/19 @ 9:00am
- Approximately 15 yards of soil was hauled off.
- The excavation was 12'x12'x6' deep
