Pit or Below-Grade Tank Registration or Closure

Operator: Elm Ridge Resources Telephone: (505) 632-3476 e-mail address: amackey1@elmridge.net
Address: #20 CR 5060, Bloomfield, New Mexico, 87413
Facility or well name: Jicarilla Apache "F" No. 10 API #: 3003982339 U/L or Qtr/Qtr C Sec 16 T 25N R 5W
County: Rio Arriba Latitude 36.397304 Longitude -107.36186 NAD: 1927 ☒ 1983 ☐
Surface Owner: Federal ☐ State ☐ Private ☐ Indian ☒

FIELD REPORT: CLOSURE VERIFICATION

LOCATION: NAME: Jicarilla Apache F WELL #: 10 PIT: earth
QUAD/UNIT: C SEC: 16 TWP: 25N RNG: 5W PM: NMPM CNTY: RA ST: NM
QTR/FOOTAGE: 1190 FNL 1980 FWL CONTRACTOR: Franks

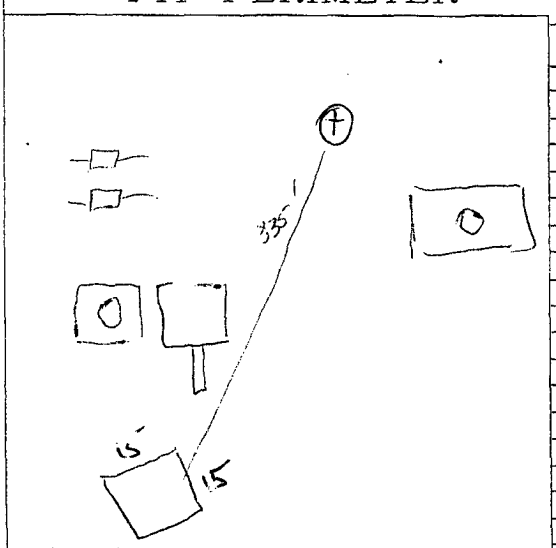
PIT PERIMETER

Approximately 20 cubic yards of contaminated soil was excavated and transported to Envirotech's NMOCD permitted Landfarm #2. Maximum reasonable extent reached at 7' BGS at hard sandstone layer. BTEX results Attached. Pit sprayed with Potassium permanganate

TIME	SAMPLE I.D.	LAB No:	WEIGHT (g)	mL. FREON	DILUTION	READING	CALC. ppm
1300	Composite (6 point)		5.0	20	40	218	8,720
1460	Bottom Sandstone		5.0	20	40	262	10,480
1615	walls		5.0	20	4	67	268

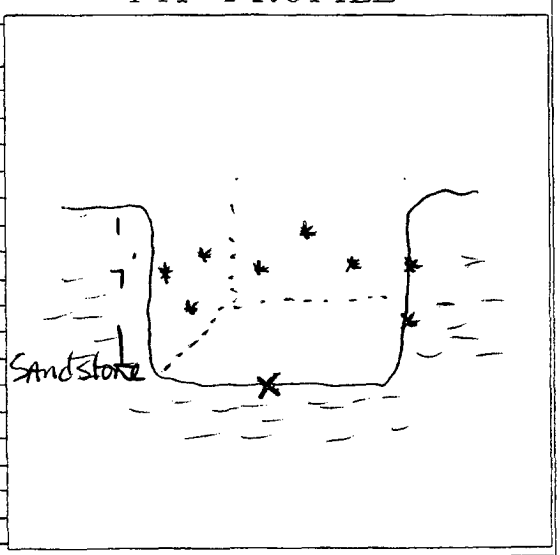
PIT PROFILE

EXCAVATION APPROX. 15 FT. x 15 FT. x 7 FT. DEEP. CUBIC YARDAGE: 20
DISPOSAL FACILITY: Envirotech Landfarm #2 REMEDIATION METHOD: Landfarm
LAND USE: grazing LEASE: _____ FORMATION: _____
