Pit or Below-Grade Tank Registration or Closure

Operator: BP AMERICA PROD. CO. Telephone: (505)-326-9200 e-mail address:
Address: 200 ENERGY COURT. FARMINGTON. NM 87410
Facility or well name: **HORTON LS #2** API #: **30-045- 20673** U/L or Qtr/Qtr **M** Sec **29** T **32N** R **11W**
County: **SAN JUAN** Latitude **36.95202** Longitude **108.01637** NAD: 1927 ☐ 1983 ☒ Surface Owner Federal ☒ State ☐ Private ☐ Indian ☐

FIELD REPORT: PIT CLOSURE VERIFICATION

LOCATION: NAME: HORTON LS WELL #: 2 TYPE: BLOW
QUAD/UNIT: M SEC: 29 TWP: 32N RNG: 11W PM: SJ CNTY: NM ST: SJ
QTR/FOOTAGE: 1100 FSL x 1050 FWL SW/SW CONTRACTOR: P+S (MAMO)

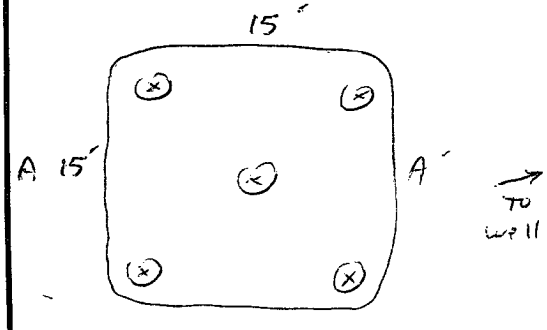
PIT PERIMETER

SOIL TYPE: (SAND / SILTY SAND) SILT / SILTY CLAY / CLAY / GRAVEL / OTHER
SOIL COLOR: Lite Tan
COHESION (ALL OTHERS): NON COHESIVE (SLIGHTLY COHESIVE) COHESIVE / HIGHLY COHESIVE
CONSISTENCY (NON COHESIVE SOILS): LOOSE (FIRM) DENSE / VERY DENSE
PLASTICITY (CLAYS): NON PLASTIC / SLIGHTLY PLASTIC / COHESIVE / MEDIUM PLASTIC / HIGHLY PLASTIC
DENSITY (COHESIVE CLAYS & SILTS): SOFT / FIRM / STIFF / VERY STIFF / HARD
MOISTURE: DRY (SLIGHTLY MOIST) MOIST / WET / SATURATED / SUPER SATURATED
DISCOLORATION/STAINING OBSERVED: (YES) / NO EXPLANATION - Gray / BLACK
HC ODOR DETECTED: (YES) / NO EXPLANATION - Moderate
SAMPLE TYPE: GRAB / (COMPOSITE) # OF PTS. 5
ADDITIONAL COMMENTS: 12' x 12' x 3' Deep Earthen Pit. Excavated Impacted Soils to 10' Depth (Equip Limits) & Sample

SAMPLE ID	FIELD HEADSPACE (ppm)
1 @	
2 @	
3 @	
4 @	
5 @	
5-POINT	200
COMPOSITE @ 10'

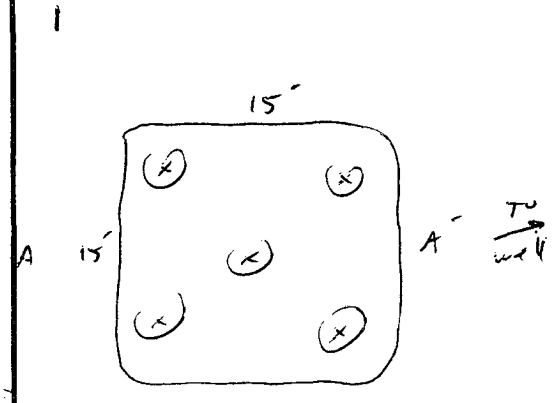
PIT PERIMETER

SOIL TYPE: (SAND / SILTY SAND) SILT / SILTY CLAY / CLAY / GRAVEL / OTHER BEDROCK SANDSTONE @ 13'
SOIL COLOR: LITE TAN
COHESION (ALL OTHERS): NON COHESIVE / (SLIGHTLY COHESIVE) COHESIVE / HIGHLY COHESIVE
CONSISTENCY (NON COHESIVE SOILS): LOOSE / (FIRM) / DENSE / VERY DENSE
PLASTICITY (CLAYS): NON PLASTIC / SLIGHTLY PLASTIC / COHESIVE / MEDIUM PLASTIC / HIGHLY PLASTIC
DENSITY (COHESIVE CLAYS & SILTS): SOFT / FIRM / STIFF / VERY STIFF / HARD
MOISTURE: DRY / (SLIGHTLY MOIST) / MOIST / WET / SATURATED / SUPER SATURATED
DISCOLORATION/STAINING OBSERVED: (YES) / NO EXPLANATION - Lite Gray 10'-13'
HC ODOR DETECTED: (YES) / NO EXPLANATION - Moderate
SAMPLE TYPE: GRAB (COMPOSITE) # OF PTS. 5
ADDITIONAL COMMENTS: USE TRACKHOE TO EXTEND REMEDIATION BY EXCAVATION. HIT FIRM BEDROCK SANDSTONE @ 13'

SAMPLE ID	FIELD HEADSPACE (ppm)
1 @	
2 @	
3 @	
4 @	
5 @	
5-POINT COMPOSITE @ 0-13'	236

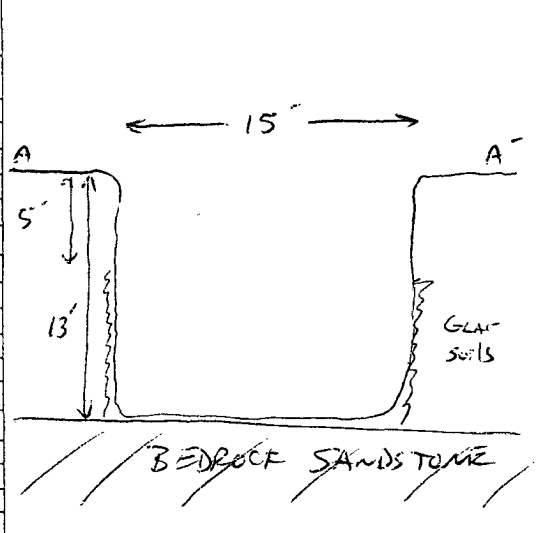
PIT PROFILE

BEDROCK BOTTOM

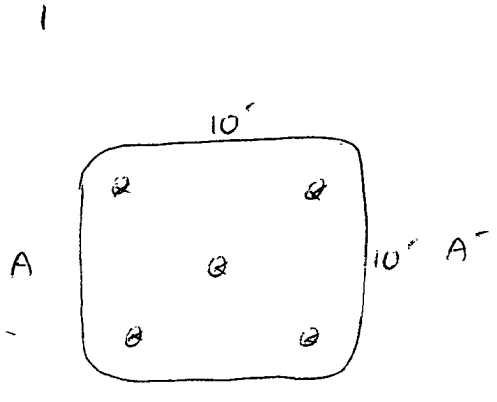
PIT PERIMETER

SOIL TYPE: (SAND) / SILTY SAND / SILT / SILTY CLAY / CLAY / GRAVEL / OTHER
SOIL COLOR: Lite Tan
COHESION (ALL OTHERS): NON COHESIVE / (SLIGHTLY COHESIVE) / COHESIVE / HIGHLY COHESIVE
CONSISTENCY (NON COHESIVE SOILS): LOOSE / (FIRM) / DENSE / VERY DENSE
PLASTICITY (CLAYS): NON PLASTIC / SLIGHTLY PLASTIC / COHESIVE / MEDIUM PLASTIC / HIGHLY PLASTIC
DENSITY (COHESIVE CLAYS & SILTS): SOFT / FIRM / STIFF / VERY STIFF / HARD
MOISTURE: DRY / (SLIGHTLY MOIST) / MOIST / WET / SATURATED / SUPER SATURATED
DISCOLORATION/STAINING OBSERVED: YES / (NO) EXPLANATION -
HC ODOR DETECTED: YES / (NO) EXPLANATION -
SAMPLE TYPE: GRAB / (COMPOSITE) - # OF PTS. 5
ADDITIONAL COMMENTS: 10'x10'x1' Deep Earthen Pit. Use Backhoe to Dig into Pit & Sample. No evidence of Contamination.

SAMPLE ID	FIELD HEADSPACE (ppm)
1 @	
2 @	
3 @	
4 @	
5 @	
5-Point Composite @ 4'	0.0
