Pit or Below-Grade Tank Registration or Closure

FIELD REPORT: PIT CLOSURE VERIFICATION

LOCATION: NAME: DOME NAV. 33-22-6 WELL #: 2 TYPE: SEP

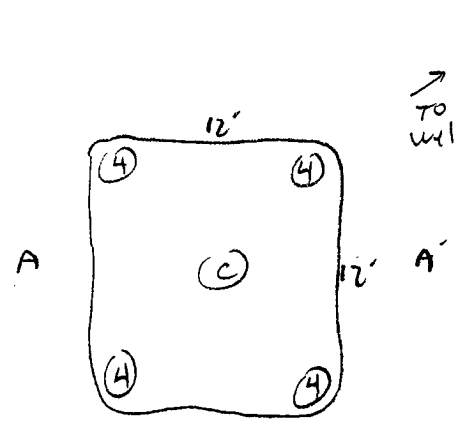
PIT PERIMETER

FIELD NOTES & REMARKS: PIT LOCATED APPROXIMATELY 42 FT. S56W FROM WELLHEAD.

SOIL TYPE: SAND / (SILTY SAND) / SILT / SILTY CLAY / CLAY / GRAVEL / OTHER
SOIL COLOR: TAN
COHESION (ALL OTHERS): (NON COHESIVE) / SLIGHTLY COHESIVE / COHESIVE / HIGHLY COHESIVE
CONSISTENCY (NON COHESIVE SOILS): (LOOSE) / FIRM / DENSE / VERY DENSE
PLASTICITY (CLAYS): NON PLASTIC / SLIGHTLY PLASTIC / COHESIVE / MEDIUM PLASTIC / HIGHLY PLASTIC
DENSITY (COHESIVE CLAYS & SILTS): SOFT / FIRM / STIFF / VERY STIFF / HARD
MOISTURE: (DRY / SLIGHTLY MOIST) / MOIST / WET / SATURATED / SUPER SATURATED
DISCOLORATION/STAINING OBSERVED: YES / (NO) EXPLANATION -
HC ODOR DETECTED: YES / (NO) EXPLANATION -
SAMPLE TYPE: GRAB / COMPOSITE - # OF PTS.
ADDITIONAL COMMENTS: 12'x12'x3'± UNLINED PIT. USE BACKHOE TO DIG INTO PIT & SAMPLE.
