Pit or Below-Grade Tank Registration or Closure

Operator: Dugan Production Corp Telephone: (505)325-1821 e-mail address: _____
Address: P.O. Box 420, Farmington, New Mexico 87401
Facility or well name: Dome Nav. 33-22-6 #1 API #: 30-043-20663 U/L or Qtr/Qtr A Sec 33 T 22N R 6W
County: Sandoval Latitude 36.09927 Longitude 107.46866 NAD: 1927 ☐ 1983 ☐ Surface Owner Federal ☐ State ☐ Private ☐ Indian ☒

FIELD REPORT: PIT CLOSURE VERIFICATION

LOCATION: NAME: DOME NAV. 33-22-6 WELL #: 1 TYPE: SEP
QUAD/UNIT: A SEC: 33 TWP: 22N RNG: 6W PM: NM CNTY: SN ST: NM
QTR/FOOTAGE: 790 FNL x 790 FEL CONTRACTOR: SIERRA - HARVEY

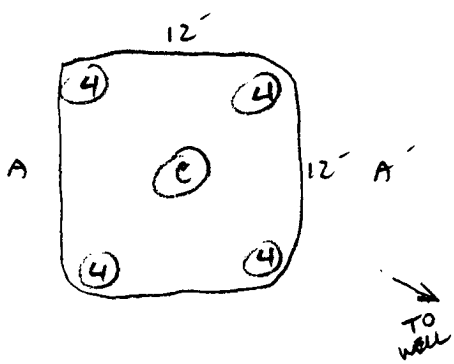
PIT PERIMETER

FIELD NOTES & REMARKS: PIT LOCATED APPROXIMATELY 54' FT. N86W FROM WELLHEAD.
DEPTH TO GROUNDWATER: >100 NEAREST WATER SOURCE: >1000 NEAREST SURFACE WATER: >1000
NMOCD RANKING SCORE: 0 NMOCD TPH CLOSURE STD: 5000 PPM

SOIL TYPE: SAND (SILTY SAND) SILT / SILTY CLAY / CLAY / GRAVEL / OTHER
SOIL COLOR: TAN
COHESION (ALL OTHERS): NON COHESIVE / (SLIGHTLY COHESIVE) COHESIVE / HIGHLY COHESIVE
CONSISTENCY (NON COHESIVE SOILS): LOOSE / (FIRM) / DENSE / VERY DENSE
PLASTICITY (CLAYS): NON PLASTIC / SLIGHTLY PLASTIC / COHESIVE / MEDIUM PLASTIC / HIGHLY PLASTIC
DENSITY (COHESIVE CLAYS & SILTS): SOFT / FIRM / STIFF / VERY STIFF / HARD
MOISTURE: DRY / (SLIGHTLY MOIST) / MOIST / WET / SATURATED / SUPER SATURATED
DISCOLORATION/STAINING OBSERVED: YES (NO) EXPLANATION -
HC ODOR DETECTED: YES (NO) EXPLANATION -
SAMPLE TYPE: GRAB / COMPOSITE - # OF PTS.
ADDITIONAL COMMENTS: 12' x 12' x 2' ± Deep Unlined Pit. USE BACKHOE TO DIG INTO PIT & SAMPLE
