Pit or Below-Grade Tank Registration or Closure

Operator: BP AMERICA PROD. CO. Telephone: (505)-326-9200 e-mail address:
Address: 200 ENERGY COURT. FARMINGTON. NM 87410
Facility or well name: FLORANCE F LS #3 API #: 30-045- 20849 U/L or Qtr/Qtr O Sec 25 T 30N R 10W
County: SAN JUAN Latitude 36.77862 Longitude 107.83295 NAD: 1927 ☐ 1983 ☒ Surface Owner Federal ☒ State ☐ Private ☐ Indian ☐

FIELD REPORT: PIT CLOSURE VERIFICATION

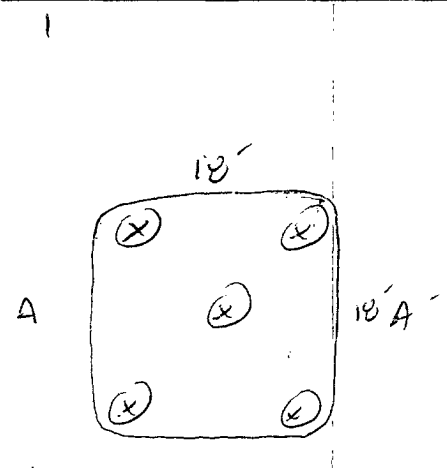
PIT PERIMETER

FIELD NOTES & REMARKS: PIT LOCATED APPROXIMATELY 21 FT. N47E FROM WELLHEAD.
DEPTH TO GROUNDWATER: >100 NEAREST WATER SOURCE: >1000 NEAREST SURFACE WATER: >1000
NMOCD RANKING SCORE: 0 NMOCD TPH CLOSURE STD: 5000 PPM

SOIL TYPE: (SAND) / SILTY SAND / SILT / SILTY CLAY / CLAY / GRAVEL / OTHER
SOIL COLOR: Yellow TAN
COHESION (ALL OTHERS): (NON COHESIVE) / SLIGHTLY COHESIVE / COHESIVE / HIGHLY COHESIVE
CONSISTENCY (NON COHESIVE SOILS): (LOOSE) / FIRM / DENSE / VERY DENSE
PLASTICITY (CLAYS): NON PLASTIC / SLIGHTLY PLASTIC / COHESIVE / MEDIUM PLASTIC / HIGHLY PLASTIC
DENSITY (COHESIVE CLAYS & SILTS): SOFT / FIRM / STIFF / VERY STIFF / HARD
MOISTURE: DRY / (SLIGHTLY MOIST) / MOIST / WET / SATURATED / SUPER SATURATED
DISCOLORATION/STAINING OBSERVED: (YES) / NO EXPLANATION - V Minor Gray
HC ODOR DETECTED: (YES) / NO EXPLANATION - V-Minor
SAMPLE TYPE: GRAB / (COMPOSITE) # OF PTS. 5
ADDITIONAL COMMENTS: 12'x12'x2' Deep Earthen Pit. Use BACKHOE to Dig into Pit & Test.
