Pit or Below-Grade Tank Registration or Closure

Operator: Burlington Resources Telephone: (505) 326-9841 e-mail address: LHasely@br-inc.com
Address: 3401 East 30th Street, Farmington, New Mexico, 87402
Facility or well name: Huerfano Unit 283 API #: 30045238350000 U/L or Qtr/Qtr O Sec 35 T 26N R 9W
County: San Juan Latitude 36.43958 Longitude -107.75510 NAD: 1927 ☒ 1983 ☐
Surface Owner: Federal ☒ State ☐ Private ☐ Indian ☐

FIELD REPORT: CLOSURE VERIFICATION

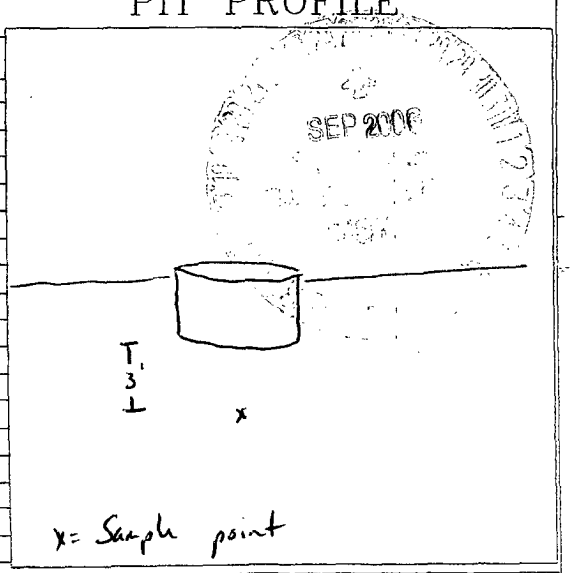
PIT PROFILE

FIELD NOTES & REMARKS: PIT LOCATED APPROXIMATELY 46' FT. 80° FROM WELLHEAD.
DEPTH TO GROUNDWATER: 0 NEAREST WATER SOURCE: 0 NEAREST SURFACE WATER: 10
NMOCD RANKING SCORE: 10 NMOCD TPH CLOSURE STD: 1000 PPM

Slight discoloration along w/ slight hydrocarbon odor below BGT. At 3' ~~Below~~ Below slight odor still present but no staining. N. soil removed from site.

SAMPLE ID	FIELD HEADSPACE PID (ppm)
13' Below	73 ppm
2	
3	
4	
5
