Pit or Below-Grade Tank Registration or Closure

Operator: BP America Production Company Telephone: (505)326-9200 e-mail address:
Address: 200 Energy Ct, Farmington, NM 87401
Facility or well name: HEATON LS #4A API #: 30045 23714 U/L or Qtr/Qtr I Sec 29 T 31 N R 11 W
County: San Juan Latitude Longitude NAD: 1927 ☐ 1983 ☒
Surface Owner: Federal ☒ State ☐ Private ☐ Indian ☐

FIELD REPORT: PIT CLOSURE VERIFICATION

LOCATION: NAME: HEATON LS WELL #: 4A TYPE: DEHY
QUAD/UNIT: I SEC: 29 TWP: 31N RNG: 11W PM: NM CNTY: SJ ST: NM
QTR/FOOTAGE: 1825'S/930'E NE/SE CONTRACTOR: HDI (HEBER)

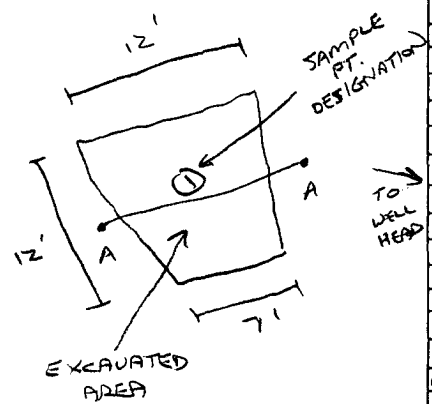
PIT PERIMETER

EXCAVATION APPROX. 9.5 FT. x 12 FT. x 4 FT. DEEP. CUBIC YARDAGE: 15

FIELD NOTES & REMARKS: PIT LOCATED APPROXIMATELY 95 FT. N67W FROM WELLHEAD.
DEPTH TO GROUNDWATER: >100' NEAREST WATER SOURCE: >1000' NEAREST SURFACE WATER: >1000'
NMOCD RANKING SCORE: 0 NMOCD TPH CLOSURE STD: 5000 PPM

BEDROCK BOTTOM

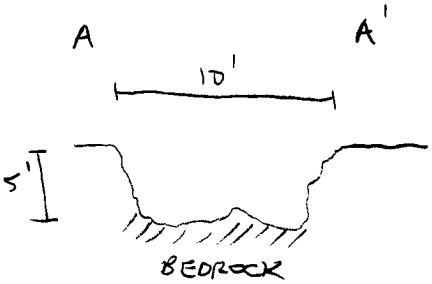
PIT PROFILE

SOIL TYPE: SAND / SILTY SAND / SILT / SILTY CLAY / CLAY / GRAVEL / OTHER BEDROCK (SHALE) BET. 3-5' BELOW GRADE
SOIL COLOR: GRAYISH ORANGE BEDROCK - OLIVE TO DK. GRAY
COHESION (ALL OTHERS): NON COHESIVE / SLIGHTLY COHESIVE / COHESIVE / HIGHLY COHESIVE
CONSISTENCY (NON COHESIVE SOILS): LOOSE / FIRM / DENSE / VERY DENSE
PLASTICITY (CLAYS): NON PLASTIC / SLIGHTLY PLASTIC / COHESIVE / MEDIUM PLASTIC / HIGHLY PLASTIC
DENSITY (COHESIVE CLAYS & SILTS): SOFT / FIRM / STIFF / VERY STIFF / HARD
MOISTURE: DRY / SLIGHTLY MOIST / MOIST / WET / SATURATED / SUPER SATURATED
DISCOLORATION/STAINING OBSERVED: (YES) NO EXPLANATION - ENTIRE EXCAVATION & PIT BOTTOM SURFACE.
HC ODOR DETECTED: (YES) NO EXPLANATION - ENTIRE PIT AREA & OVM SAMPLE.
SAMPLE TYPE: (GRAB) / COMPOSITE - # OF PTS. —
ADDITIONAL COMMENTS: COLLECTED SAMPLE FROM PIT BOTTOM SURFACE (BEDROCK). BEDROCK - FRIABLE, SOFT TO HARD.

SAMPLE ID	FIELD HEADSPACE (ppm)
1 @ 5'	585
2 @	
3 @	
4 @	
5 @

BOTH PASSED
