PIT REMEDIATION AND CLOSURE REPORT

30-045-24800

Facility Or: Hamner #3E
Well Name

Client: ConocoPhillips Company

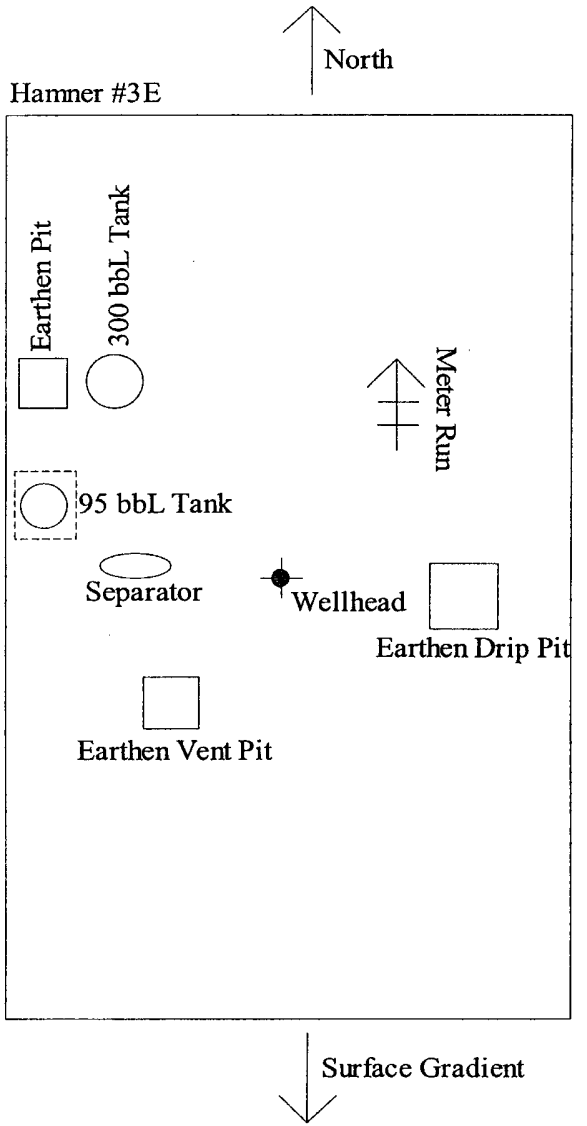
Site Diagram:

Comments:
No odor or staining at 3' below original bottom
Sandstone at sample depth
