PIT REMEDIATION AND CLOSURE REPORT

30-045-24800

Operator: ConocoPhillips Company Telephone: (505)599-3400

Facility Or: Hamner #3E
Well Name

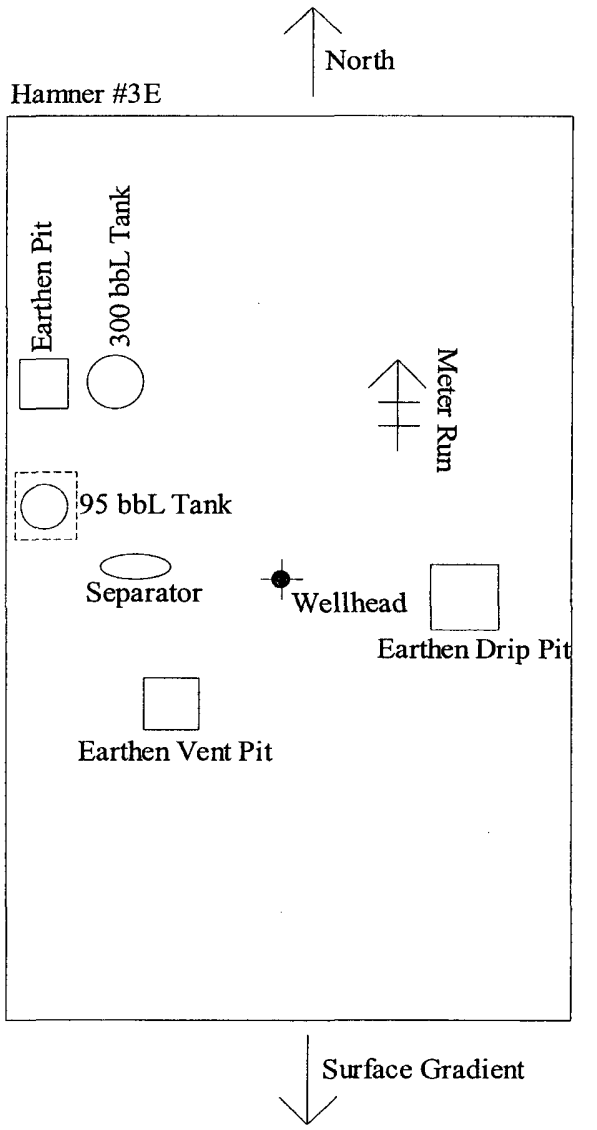
Site Diagram:

Sample location Center of pit, 5-ft below surface level (3-ft. below pit bottom)

Comments:
No odor or staining at 3' (sample depth)
