PIT REMEDIATION AND CLOSURE REPORT

Operator: ConocoPhillips Company Telephone: (505)599-3400

Facility Or: Hamner #3E
Well Name

Location: Unit or Qtr/Qtr Sec M Sec 29 T 29N R 9W County San Juan

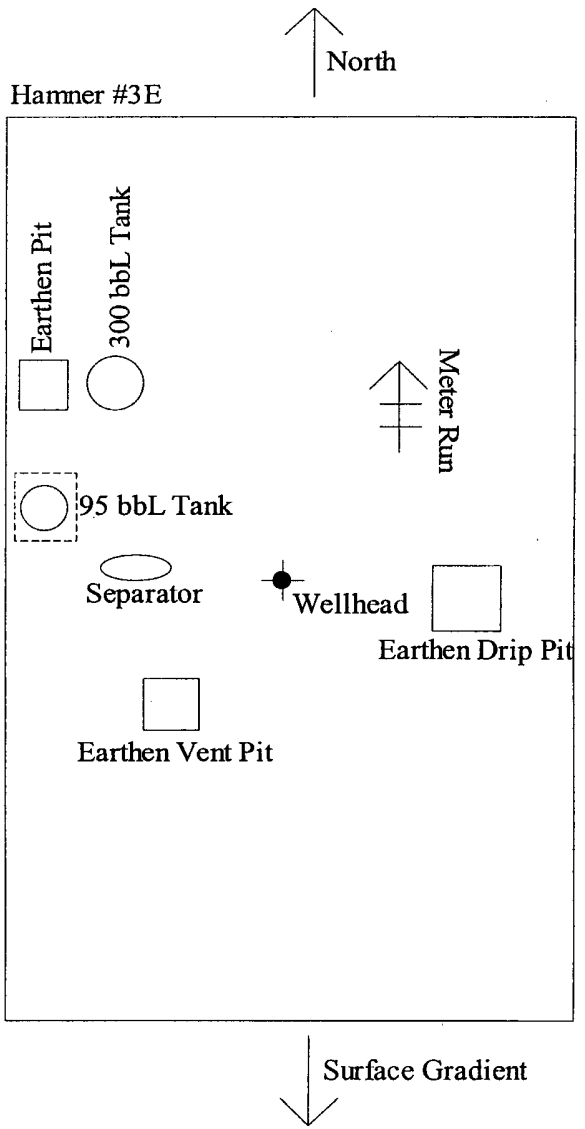
Site Diagram:

A soil sample was extracted at 6-ft below ground level (3-ft. below pit bottom). The sample was analyzed for GRO/DRO and Btex analysis. All analyses were within BLM and NMOCD requirements.

Comments:
Strong odor
Staining at 1' below pit bottom
Bedrock at sample depth
