PIT REMEDIATION AND CLOSURE REPORT

Operator: ConocoPhillips Company Telephone: (505) 599-3400

Facility Or: Schlosser Wn Fed. #7 API # :30-045-06613
Well Name

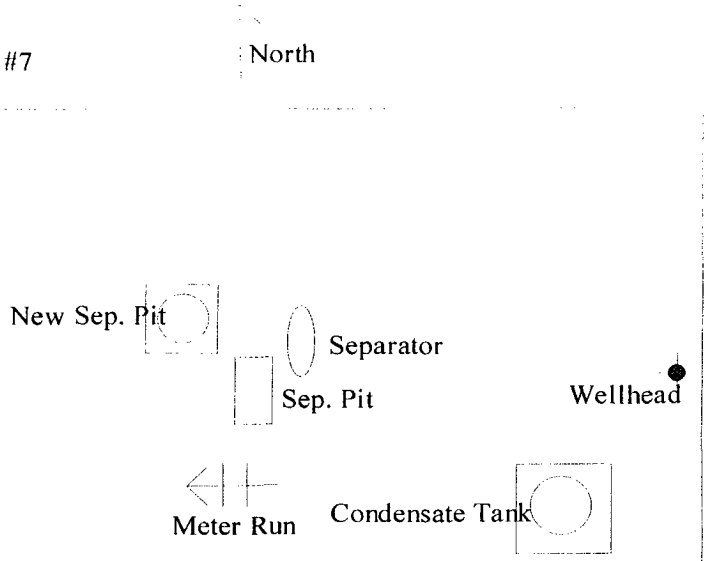
Site Diagram:

Comments:
Gray layer of soil at 20' below surface level with a strong odor.
