PIT REMEDIATION AND CLOSURE REPORT

Operator: ConocoPhillips Company Telephone: (505) 599-3400

Facility Or: Storey C LS #6 API # : 30-045-07352
Well Name

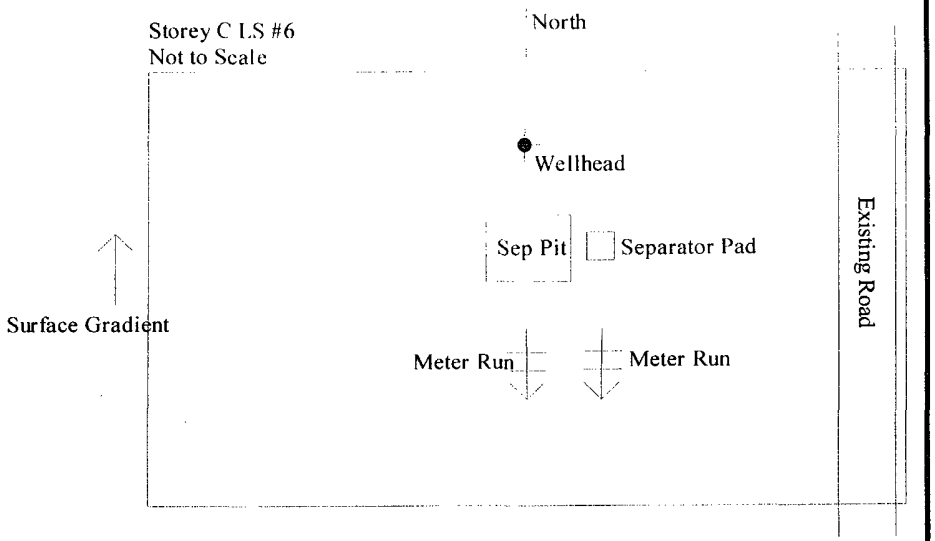
Site Diagram:

Comments:
Chicken wire with bird netting.
Could not get to center of pit.
Gray soil layer from 6" to bottom
