PIT REMEDIATION AND CLOSURE REPORT

Operator: ConocoPhillips Company Telephone: (505) 599-3400

Facility Or: Krause Wn Fed #5 API # : 30-045-07206
Well Name

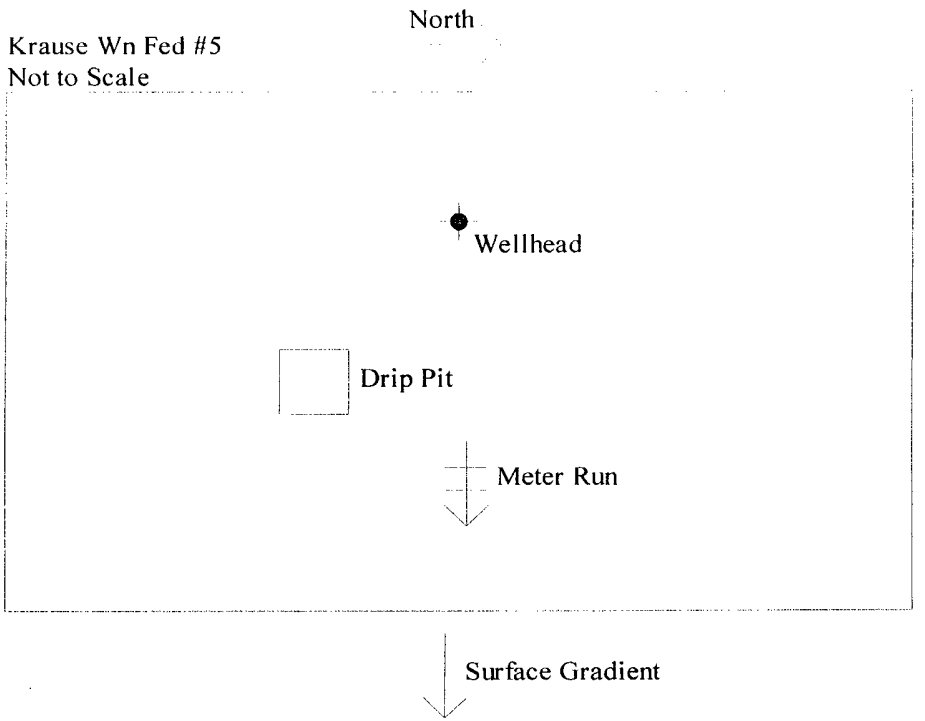
Site Diagram:

A soil sample was extracted at 6-ft below ground level (3-ft. below pit bottom). The sample was analyzed for GRO/DRO and BTEX analysis. All analyses were within BLM and NMOCD requirements.

Sample location Center of pit, 6-ft below surface level (3-ft. below pit bottom)

Sample depth 3-ft. below pit bottom
