Meter Number:89645
Location Name:CANDADO 17A CH, MV
Location:TN-26 RG-07
SC-10 UL-I
2 - Federal
NMOCD Zone:OUTSIDE
Hazard Ranking Score:00

RATIONALE FOR RISK-BASED CLOSURE OF PRODUCTION PITS LOCATED OUTSIDE OF THE VULNERABLE ZONE IN THE SAN JUAN BASIN

FIELD PIT SITE ASSESSMENT FORM

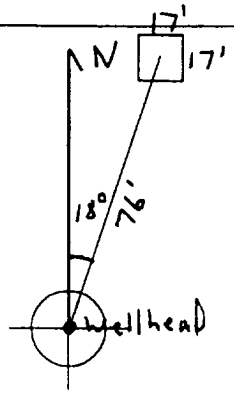
ORIGINAL PIT LOCATION

Original Pit : a) Degrees from North 18° Footage from Wellhead 76'

b) Length : 17' Width : 17' Depth : 4'
