Meter Number:74618
Location Name:HUERFANO UNIT #93
Location:TN-26 RG-09
SC-22 UL-D
2 - Federal
NMOCD Zone:OUTSIDE
Hazard Ranking Score:00

RATIONALE FOR RISK-BASED CLOSURE OF PRODUCTION PITS LOCATED OUTSIDE OF THE VULNERABLE ZONE IN THE SAN JUAN BASIN

FIELD PIT SITE ASSESSMENT FORM

FIELD PIT REMEDIATION/CLOSURE FORM

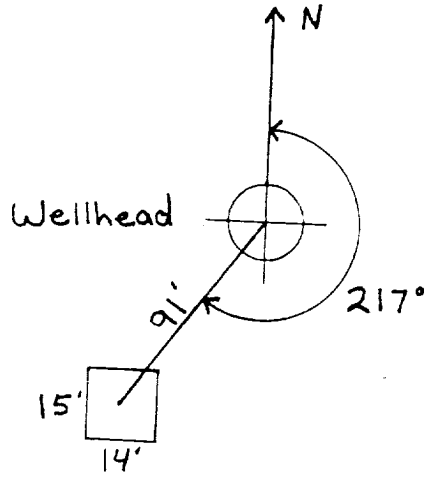
ORIGINAL PIT LOCATION

Original Pit : a) Degrees from North 217 Footage from Wellhead 91

b) Length : 15 Width : 14 Depth : 2
