Meter Number:90061
Location Name:VALENCIA CANYON UNIT #14
Location:TN-28 RG-04
SC-23 UL-D
2 - Federal
NMOCD Zone:OUTSIDE
Hazard Ranking Score:00

RATIONALE FOR RISK-BASED CLOSURE OF PRODUCTION PITS LOCATED OUTSIDE OF THE VULNERABLE ZONE IN THE SAN JUAN BASIN

FIELD PIT SITE ASSESSMENT FORM

FIELD PIT REMEDIATION/CLOSURE FORM

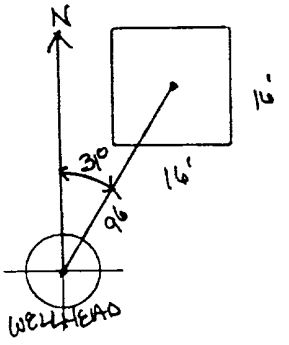
Remarks : REDLINE & TOPO SHOW LOCATION OUTSIDE V.Z. THREE PITS ON LOCATION. LOCATION DRIP BELONGS TO EPNG. WILL CLOSE PIT.

ORIGINAL PIT LOCATION

Original Pit : a) Degrees from North 310 Footage from Wellhead 96'

b) Length : 16' Width : 16' Depth : 2'
