Meter Number:93215
Location Name:SAN JUAN 28-7 UT #12A PC
Location:TN-28 RG-07
SC-17 UL-C
2 - Federal
NMOCD Zone:OUTSIDE
Hazard Ranking Score:00

RATIONALE FOR RISK-BASED CLOSURE OF PRODUCTION PITS LOCATED OUTSIDE OF THE VULNERABLE ZONE IN THE SAN JUAN BASIN

FIELD PIT SITE ASSESSMENT FORM

FIELD PIT REMEDIATION/CLOSURE FORM

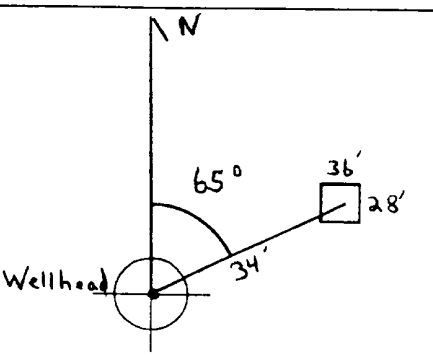
ORIGINAL PIT LOCATION

Original Pit : a) Degrees from North 65° Footage from Wellhecd 34'

b) Length : 36' Width : 28' Depth : 4'
