Meter Number:93688
Location Name:San Juan 28-7 #231E
Location:TN-28 RG-07
SC-16 UL-K
2 - Federal
NMOCD Zone:OUTSIDE
Hazard Ranking Score:00

RATIONALE FOR RISK-BASED CLOSURE OF PRODUCTION PITS LOCATED OUTSIDE OF THE VULNERABLE ZONE IN THE SAN JUAN BASIN

FIELD PIT SITE ASSESSMENT FORM

FIELD PIT REMEDIATION/CLOSURE FORM

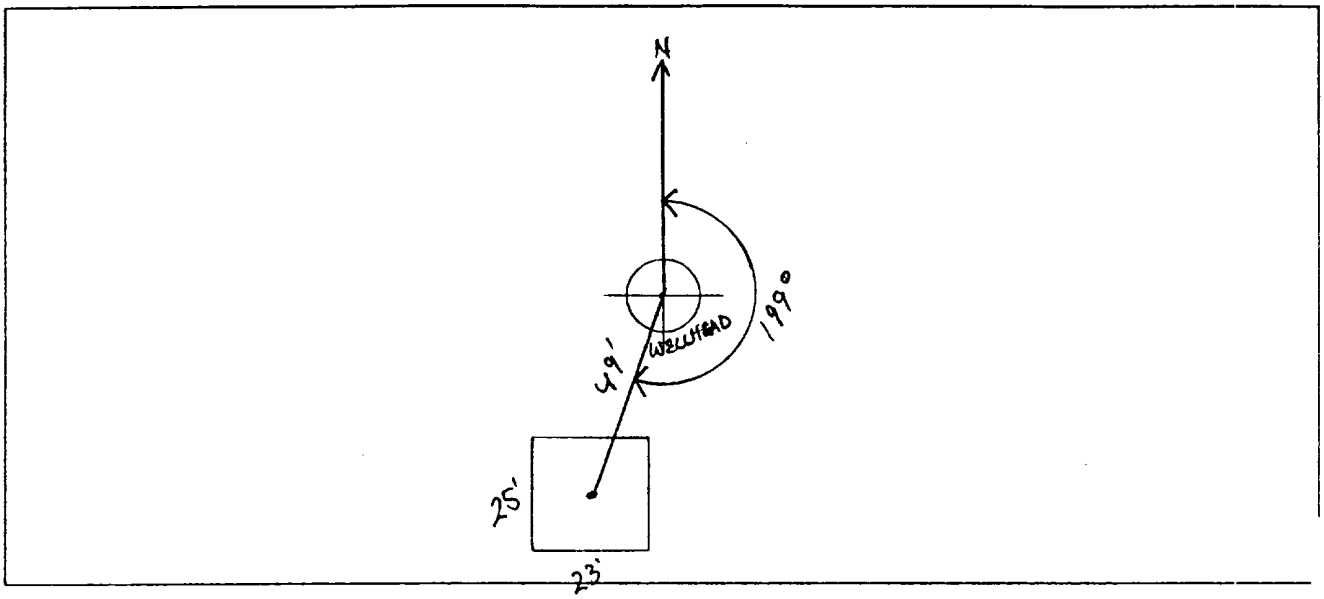
ORIGINAL PIT LOCATION

Remarks : REDLINE SHOWS INSIDE BUT TOPO SHOWS LOCATION OUTSIDE V.2. THERE ARE FOUR PITS ON THIS LOCATION. ONE IS AN UNUSED DEHY PIT AND BELONGS TO EPNG. THE OTHER THREE BELONG TO THE OPERATOR. WILL CLOSE EPNG'S PIT. PUSH IN

Original Pit : a) Degrees from North 199° Footage from Wellhead 49'

b) Length : 25' Width : 23' Depth : 3'
