Risk-based

EL PASO FIELD SERVICES
PRODUCTION PIT CLOSURE Loc. Drip

San Juan 28-7 Unit 263 PC
Meter/Line ID – 95854

REVISED
FIELD PIT SITE ASSESSMENT FORM

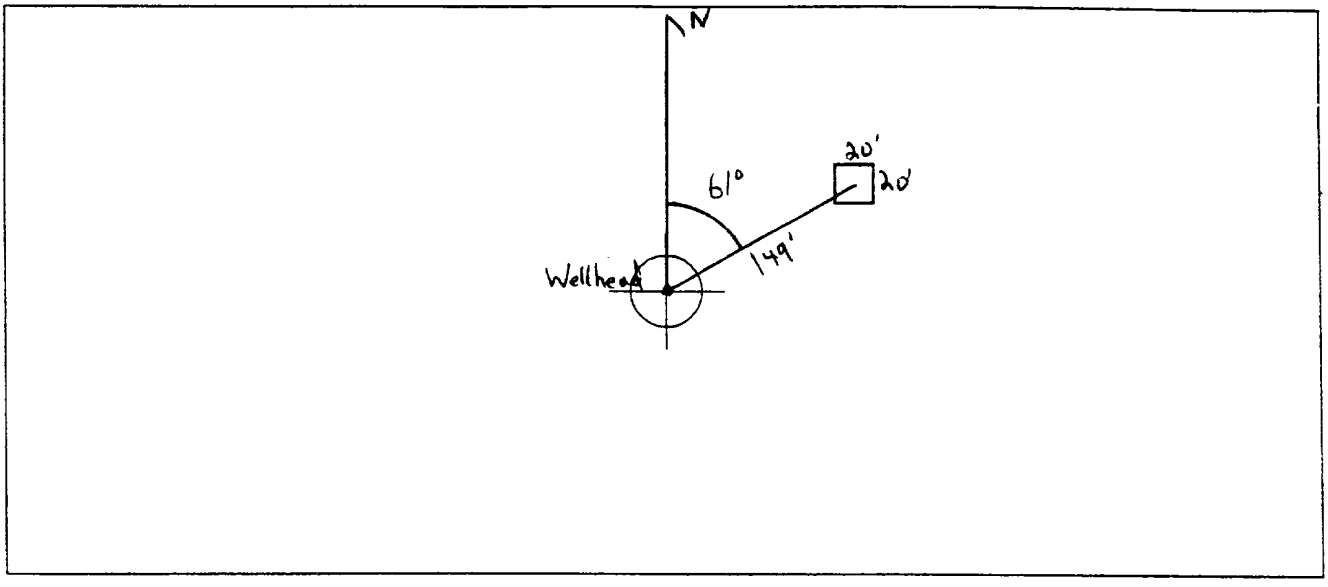
ORIGINAL PIT LOCATION

Original Pit : a) Degrees from North 61° Footage from Wellhead 149'

b) Length : 20' Width : 20' Depth : 3'
