Meter Number:72192
Location Name:FLORANCE D LS 14
Location:TN-27 RG-08
SC-21 UL-K
2 - Federal
NMOCD Zone:OUTSIDE
Hazard Ranking Score:00

RATIONALE FOR RISK-BASED CLOSURE OF PRODUCTION PITS LOCATED OUTSIDE OF THE VULNERABLE ZONE IN THE SAN JUAN BASIN

FIELD PIT SITE ASSESSMENT FORM

FIELD PIT REMEDIATION/CLOSURE FORM

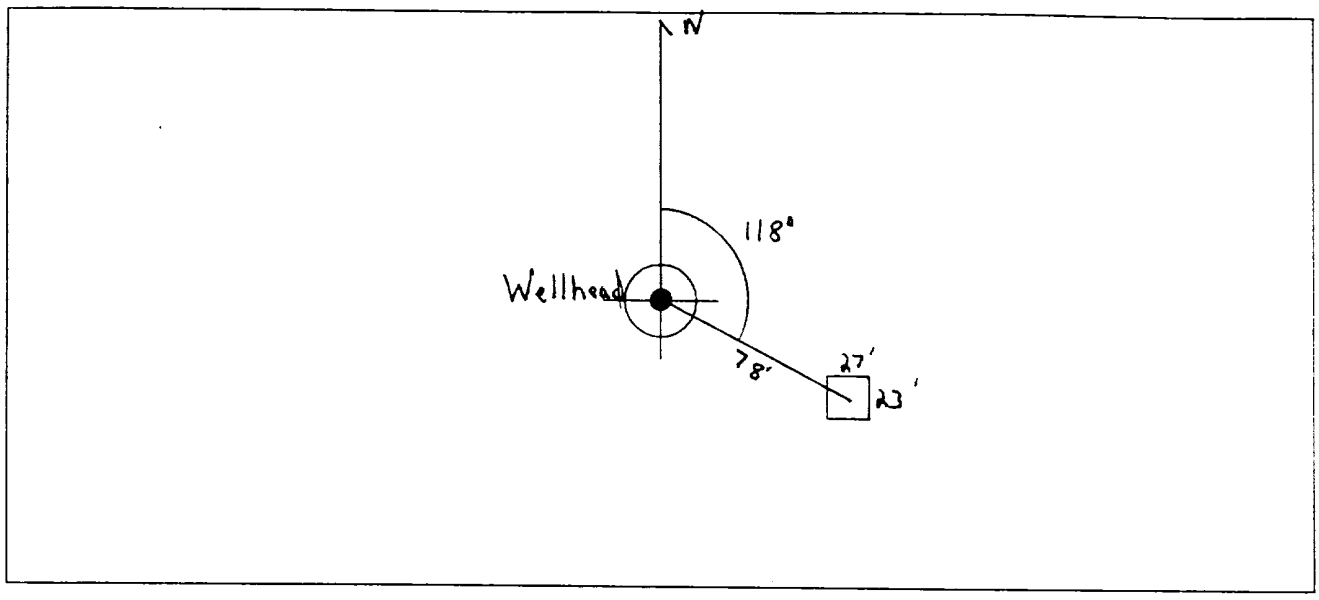
ORIGINAL PIT LOCATION

Original Pit : a) Degrees from North 118° Footage from Wellhead 78'

b) Length : 27' Width : 23' Depth : 3'
