Meter Number:74872
Location Name:FLORANCE D LS #15
Location:TN-27 RG-08
SC-17 UL-P
2 - Federal
NMOCD Zone:OUTSIDE
Hazard Ranking Score:00

RATIONALE FOR RISK-BASED CLOSURE OF PRODUCTION PITS LOCATED OUTSIDE OF THE VULNERABLE ZONE IN THE SAN JUAN BASIN

FIELD PIT REMEDIATION/CLOSURE FORM

FIELD PIT SITE ASSESSMENT FORM

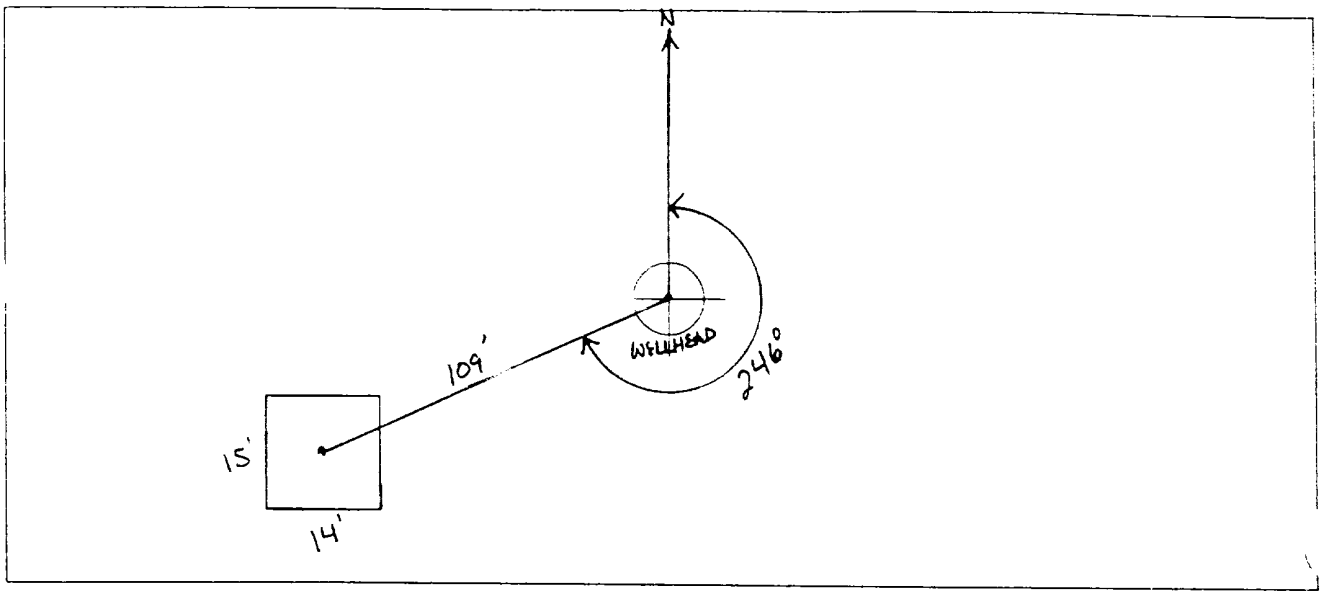
ORIGINAL PIT LOCATION

Original Pit : a) Degrees from North 246° Footage from Wellhead 109'

b) Length : 15' Width : 14' Depth : 1'
