Meter Number:75610
Location Name:SCHWERDTFEGER A 2X
Location:TN-28 RG-08
SC-31 UL-D
2 - Federal
NMOCD Zone:OUTSIDE
Hazard Ranking Score:00

RATIONALE FOR RISK-BASED CLOSURE OF PRODUCTION PITS LOCATED OUTSIDE OF THE VULNERABLE ZONE IN THE SAN JUAN BASIN

FIELD PIT SITE ASSESSMENT FORM

FIELD PIT REMEDIATION/CLOSURE FORM

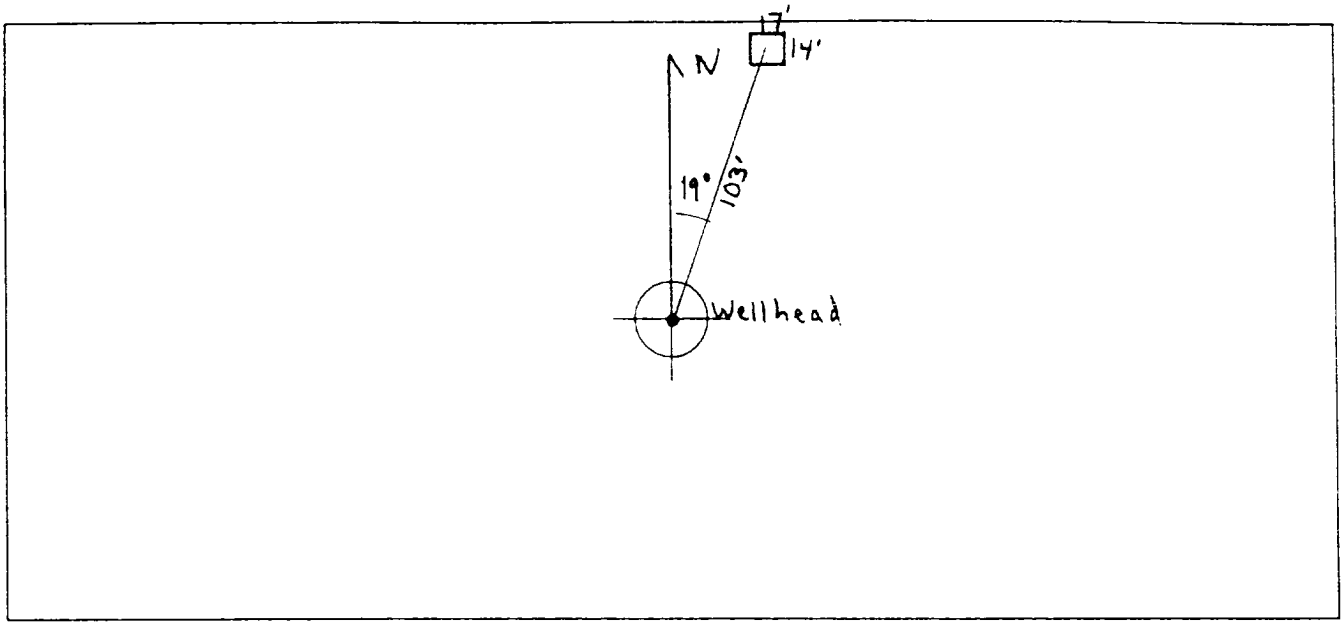
ORIGINAL PIT LOCATION

Remarks : Redline - Inside, Vulm - Outside
3 pits. Close 1. Pit Dry

Original Pit : a) Degrees from North 19° Footage from Wellhead 103'

b) Length : 17' Width : 14' Depth : 3'
