Meter Number:75328
Location Name:HUERFANITO UNIT #96
Location:TN-27 RG-09
SC-22 UL-A
2 - Federal
NMOCD Zone:OUTSIDE
Hazard Ranking Score:00

RATIONALE FOR RISK-BASED CLOSURE OF PRODUCTION PITS LOCATED OUTSIDE OF THE VULNERABLE ZONE IN THE SAN JUAN BASIN

FIELD PIT SITE ASSESSMENT FORM

FIELD PIT REMEDIATION/CLOSURE FORM

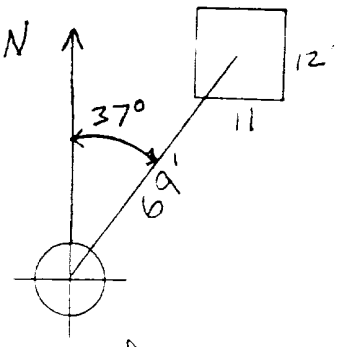
ORIGINAL PIT LOCATION

Original Pit : a) Degrees from North 37 Footage from Wellhead 69

b) Length : 12 Width : 11 Depth : 2
