Meter Number:95791
Location Name:BOLACK C LS 16 A
Location:TN-27 RG-08
SC-33 UL-I
2 - Federal
NMOCD Zone:OUTSIDE
Hazard Ranking Score:00

RATIONALE FOR RISK-BASED CLOSURE OF PRODUCTION PITS LOCATED OUTSIDE OF THE VULNERABLE ZONE IN THE SAN JUAN BASIN

FIELD PIT SITE ASSESSMENT FORM

FIELD PIT REMEDIATION/CLOSURE FORM

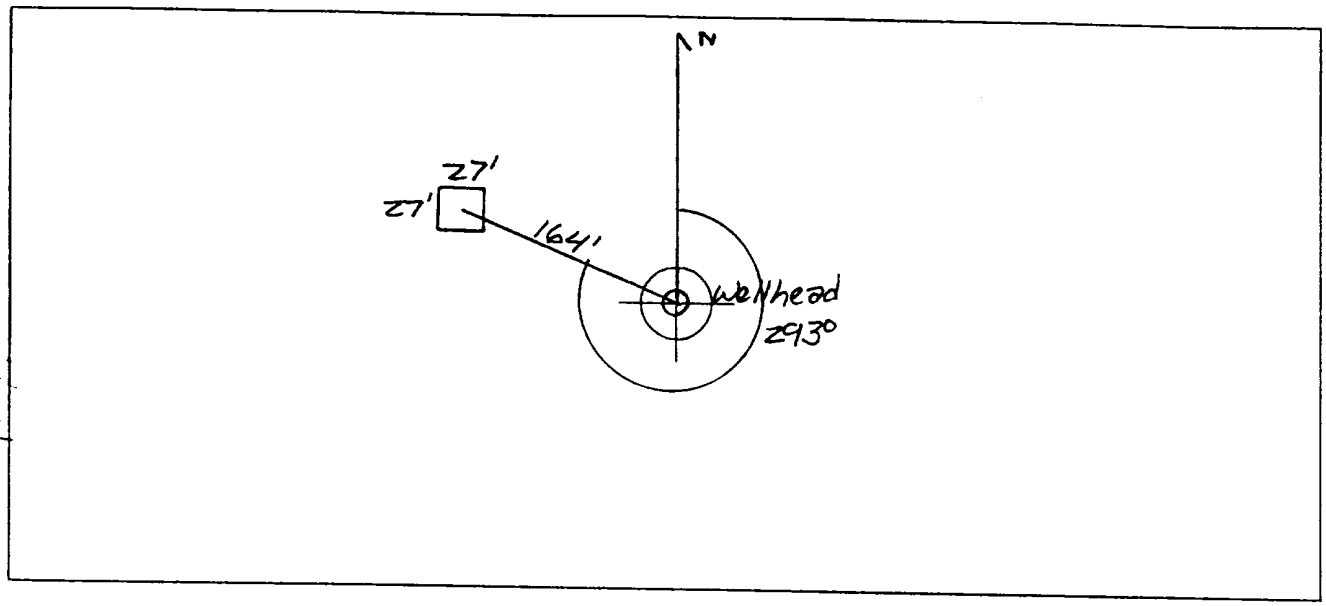
Remarks : Redline Book - Outside Vulnerable Zone Topo - Outside
Three pits on site, location drip pit has liquid in it.
Will close one pit.

Original Pit : a) Degrees from North 293° Footage from Wellhead 164'

b) Length : 27' Width : 27' Depth : 4'
