Meter Number:70403
Location Name:SAN JUAN 29-6 #13 MV
Location:TN-29 RG-06
SC-06 UL-L
2 - Federal
NMOCD Zone:OUTSIDE
Hazard Ranking Score:00

RATIONALE FOR RISK-BASED CLOSURE OF PRODUCTION PITS LOCATED OUTSIDE OF THE VULNERABLE ZONE IN THE SAN JUAN BASIN

FIELD PIT SITE ASSESSMENT FORM

FIEL_ PIT REMEDIATION/CLOSU_E FORM

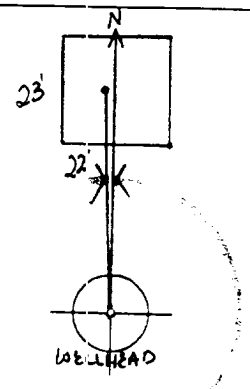
ORIGINAL PIT LOCATION

Remarks : ONLY PIT ON LOCATION. PIT IS DRY. LOCATION IS UP ON TOP OF SMITH PASS. PEDLINE AND TOPO CONFIRMED LOCATION TO BE OUTSIDE THE N.S.

Original Pit : a) Degrees from North 358° Footage from Wellhead 50'

b) Length : 23' Width : 22' Depth : 2'
