Meter Number:14077
Location Name:SAN JUAN 29-5 #69
Location:TN-28 RG-05
SC-21 UL-G
4 - Fee
NMOCD Zone:OUTSIDE
Hazard Ranking Score:00

RATIONALE FOR RISK-BASED CLOSURE OF PRODUCTION PITS LOCATED OUTSIDE OF THE VULNERABLE ZONE IN THE SAN JUAN BASIN

FIELD PIT SITE ASSESSMENT FORM

F. .D PIT REMEDIATION/CLOS RE FORM

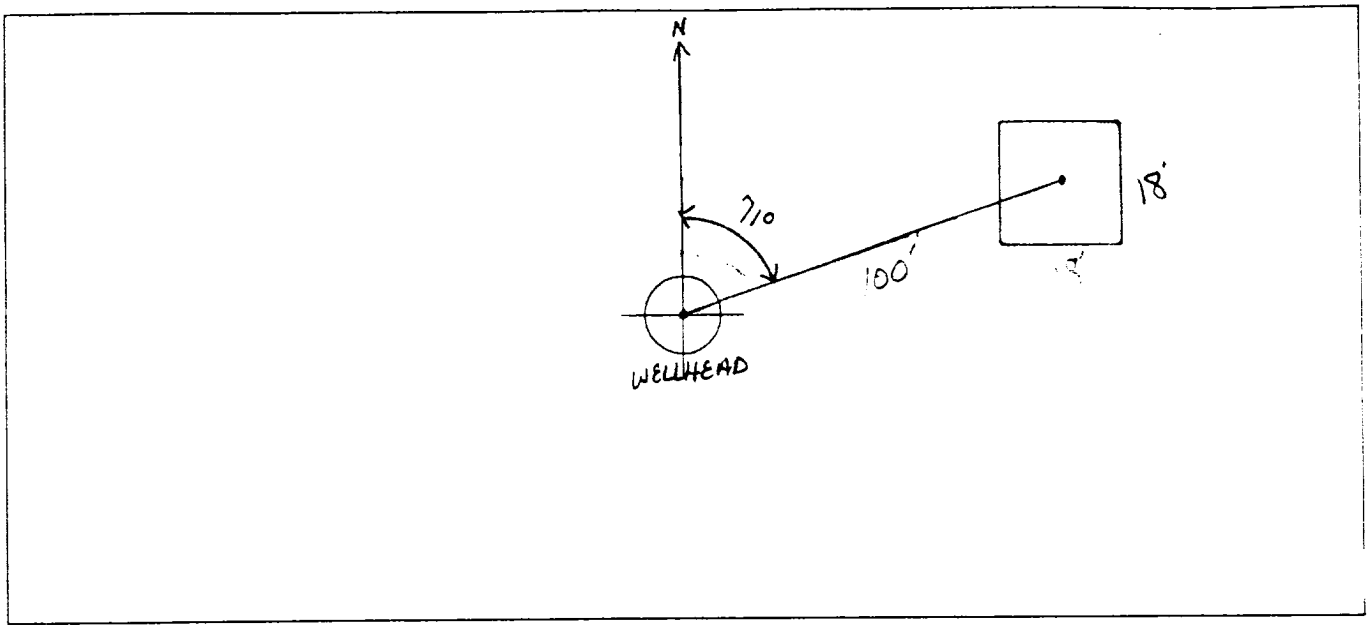
ORIGINAL PIT LOCATION

Original Pit : a) Degrees from North 71° Footage from Wellhead 100'

b) Length : 18' Width : 18' Depth : 3'
