Meter Number:70992
Location Name:SAN JUAN 30-6 UNIT #99 (Pit #1)
Location:TN-30 RG-07
SC-34 UL-M
4 - Fee
NMOCD Zone:OUTSIDE
Hazard Ranking Score:00

RATIONALE FOR RISK-BASED CLOSURE OF PRODUCTION PITS LOCATED OUTSIDE OF THE VULNERABLE ZONE IN THE SAN JUAN BASIN

FIELD PIT SITE ASSESSMENT FORM

FIELD SERVICES LABORATORY
ANALYTICAL REPORT
PIT CLOSURE PROJECT - Soil

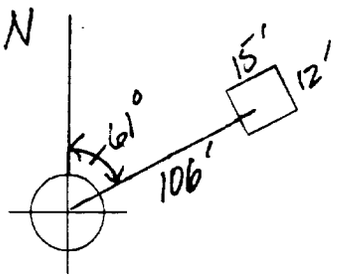
Remarks : TWO PITS ON LOCATION. CLOSE ONE PIT. PIT IS DRY. REDLINE & TOPO CONFIRMED LOCATION IS OUTSIDE V.Z.

Original Pit : a) Degrees from North 61° Footage from Wellhead 106'

b) Length : 15' Width : 12' Depth : 2'
