RATIONALE FOR RISK-BASED CLOSURE OF PRODUCTION PITS LOCATED OUTSIDE OF THE VULNERABLE ZONE IN THE SAN JUAN BASIN

FIELD PIT SITE ASSESSMENT FORM

Meter: 73921 Location: GALLEGOS CANYON UNIT #151

FIELD PIT REMEDIATION/CLOSURE FORM

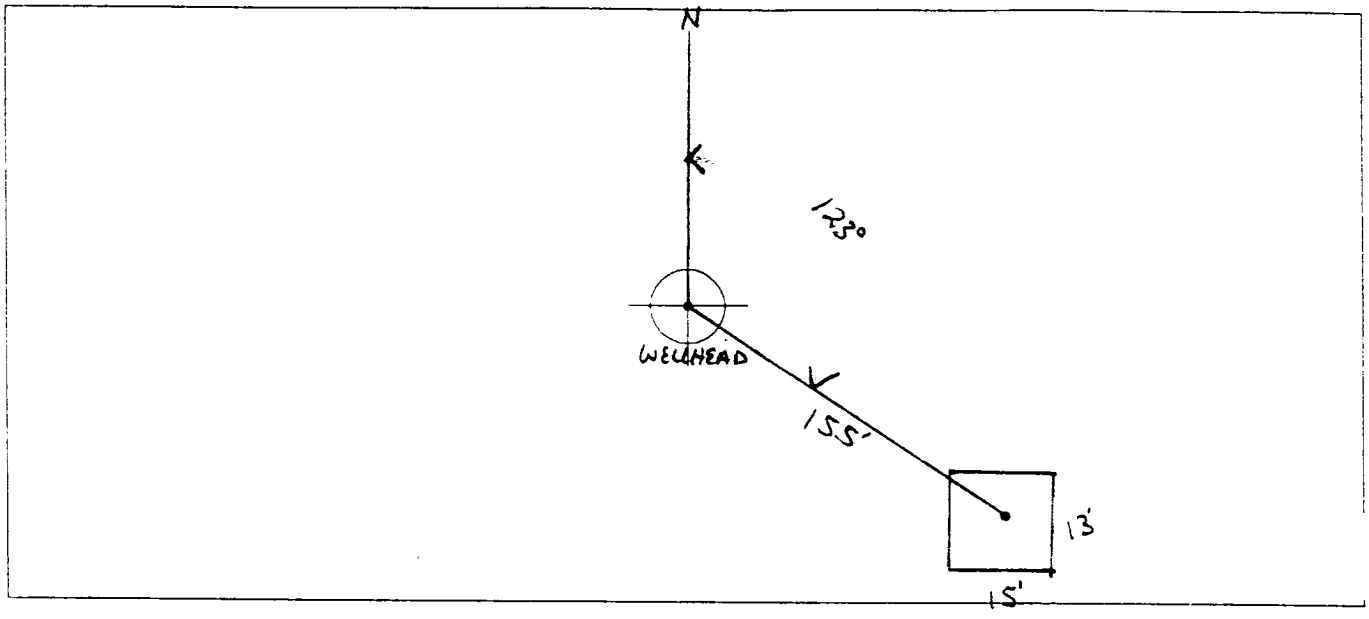
ORIGINAL PIT LOCATION

Remarks : TWO PITS ON LOCATION. WILL CLOSE ONLY ONE. PIT IS DRY. LOCATION IS UP ON TOP OF A MESA.

Original Pit : a) Degrees from North 123° Footage to Wellhead 155'

c) Length : 15' Width : 13' Depth : 3'
