Meter Number:72116
Location Name:SUNRAY F#2
Location:TN-29 RG-10
SC-01 UL-H
2 - Federal
NMOCD Zone:OUTSIDE
Hazard Ranking Score:00

RATIONALE FOR RISK-BASED CLOSURE OF PRODUCTION PITS LOCATED OUTSIDE OF THE VULNERABLE ZONE IN THE SAN JUAN BASIN

PIT SITE ASSESSMENT FORM

FIELD SERVICES LABORATORY
ANALYTICAL REPORT
PIT CLOSURE PROJECT - Soil

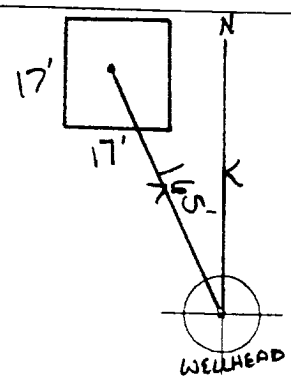
ORIGINAL PIT LOCATION

Remarks : ONLY PIT ON LOCATION. PIT IS DRY.

Original Pit : a) Degrees from North 335° Footage to Wellhead 165'

c) Length : 17' Width : 17' Depth : 3'
