Meter Number:75274
Location Name:FLORANCE #36
Location:TN-30 RG-08
SC-03 UL-H
2 - Federal
NMOCD Zone:OUTSIDE
Hazard Ranking Score:00

RATIONALE FOR RISK-BASED CLOSURE OF PRODUCTION PITS LOCATED OUTSIDE OF THE VULNERABLE ZONE IN THE SAN JUAN BASIN

FIELD PIT SITE ASSESSMENT FORM

FIEL PIT REMEDIATION/CLOSU E FORM

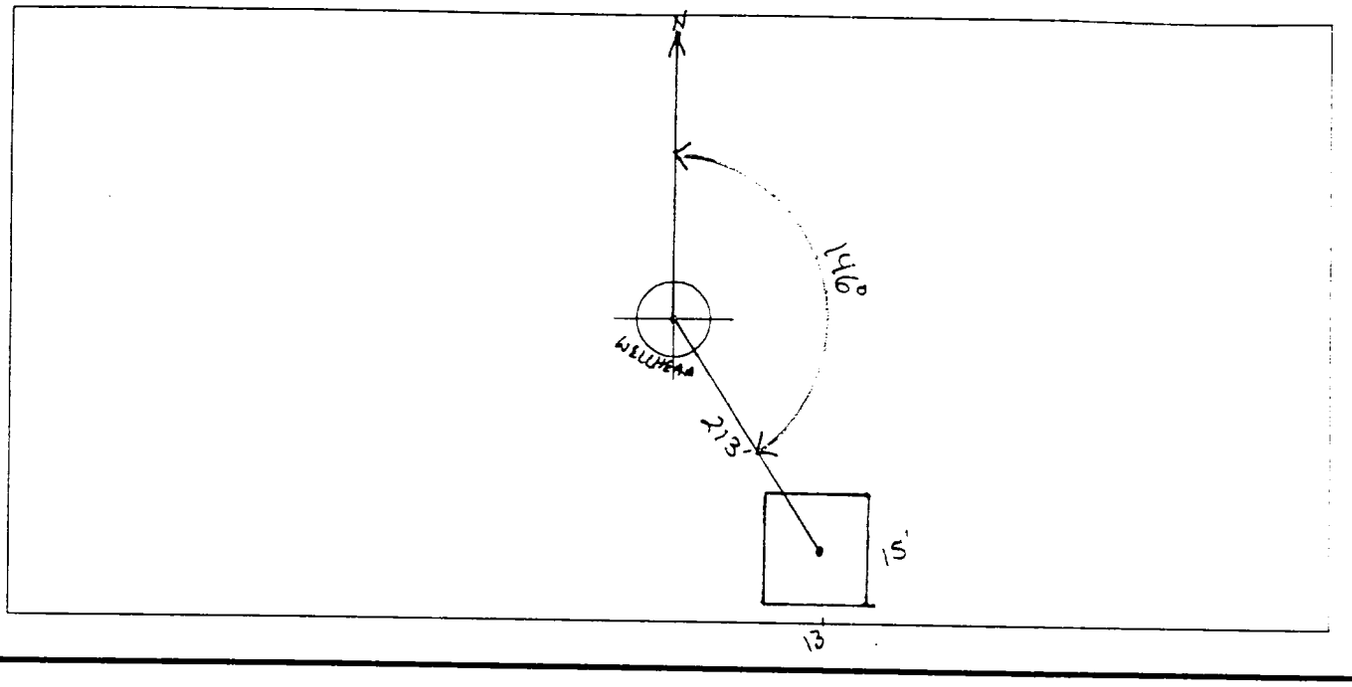
Remarks : TWO PITS ON LOCATION. WILL CLOSE ONLY ONE. PIT IS DRY. LOCATION IS ON A MESA ABOVE NAVAJO LAKE. RECLINE AND TOPO CONFIRMED LOCATION TO BE OUTSIDE THE V.Z.

Original Pit : a) Degrees from North 146° Footage from Wellhead 213'

b) Length : 15' Width : 13' Depth : 3'
