PIT REMEDIATION AND CLOSURE REPORT

Facility or Well Name: Reid A #1M

Location: Unit J Sec 13 T 29 N R 10 W County San Juan

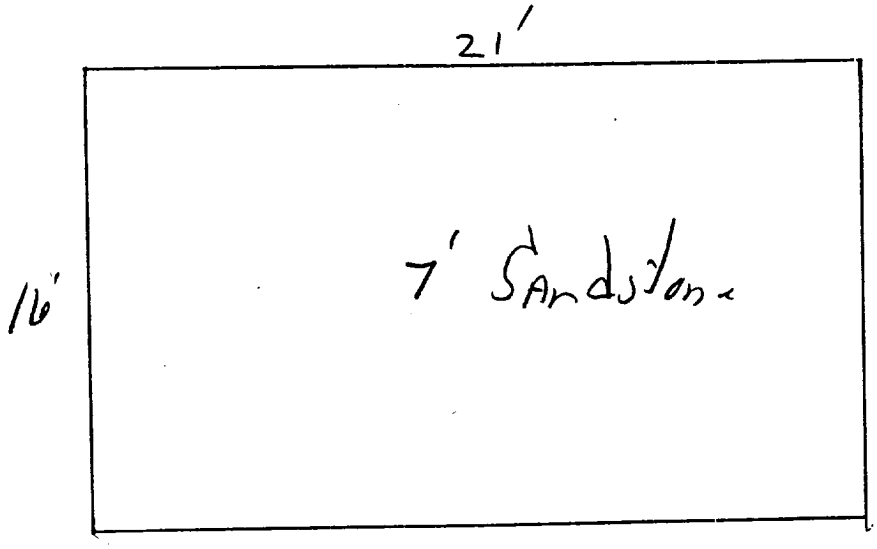
End of excavation:

*** Sandstone encountered at 7'. See attached risk analysis form.

Sample Location: 5 pt. composite - bottom.
Sample depth: 7'
Sample date: 06/09/1999 Sample time: 2:40:00 PM

Benzene (ppm): 1.7
Total BTEX (ppm): 190.8 ***
Field headspace (ppm):
TPH (ppm): 1200.00 Method: 8015B

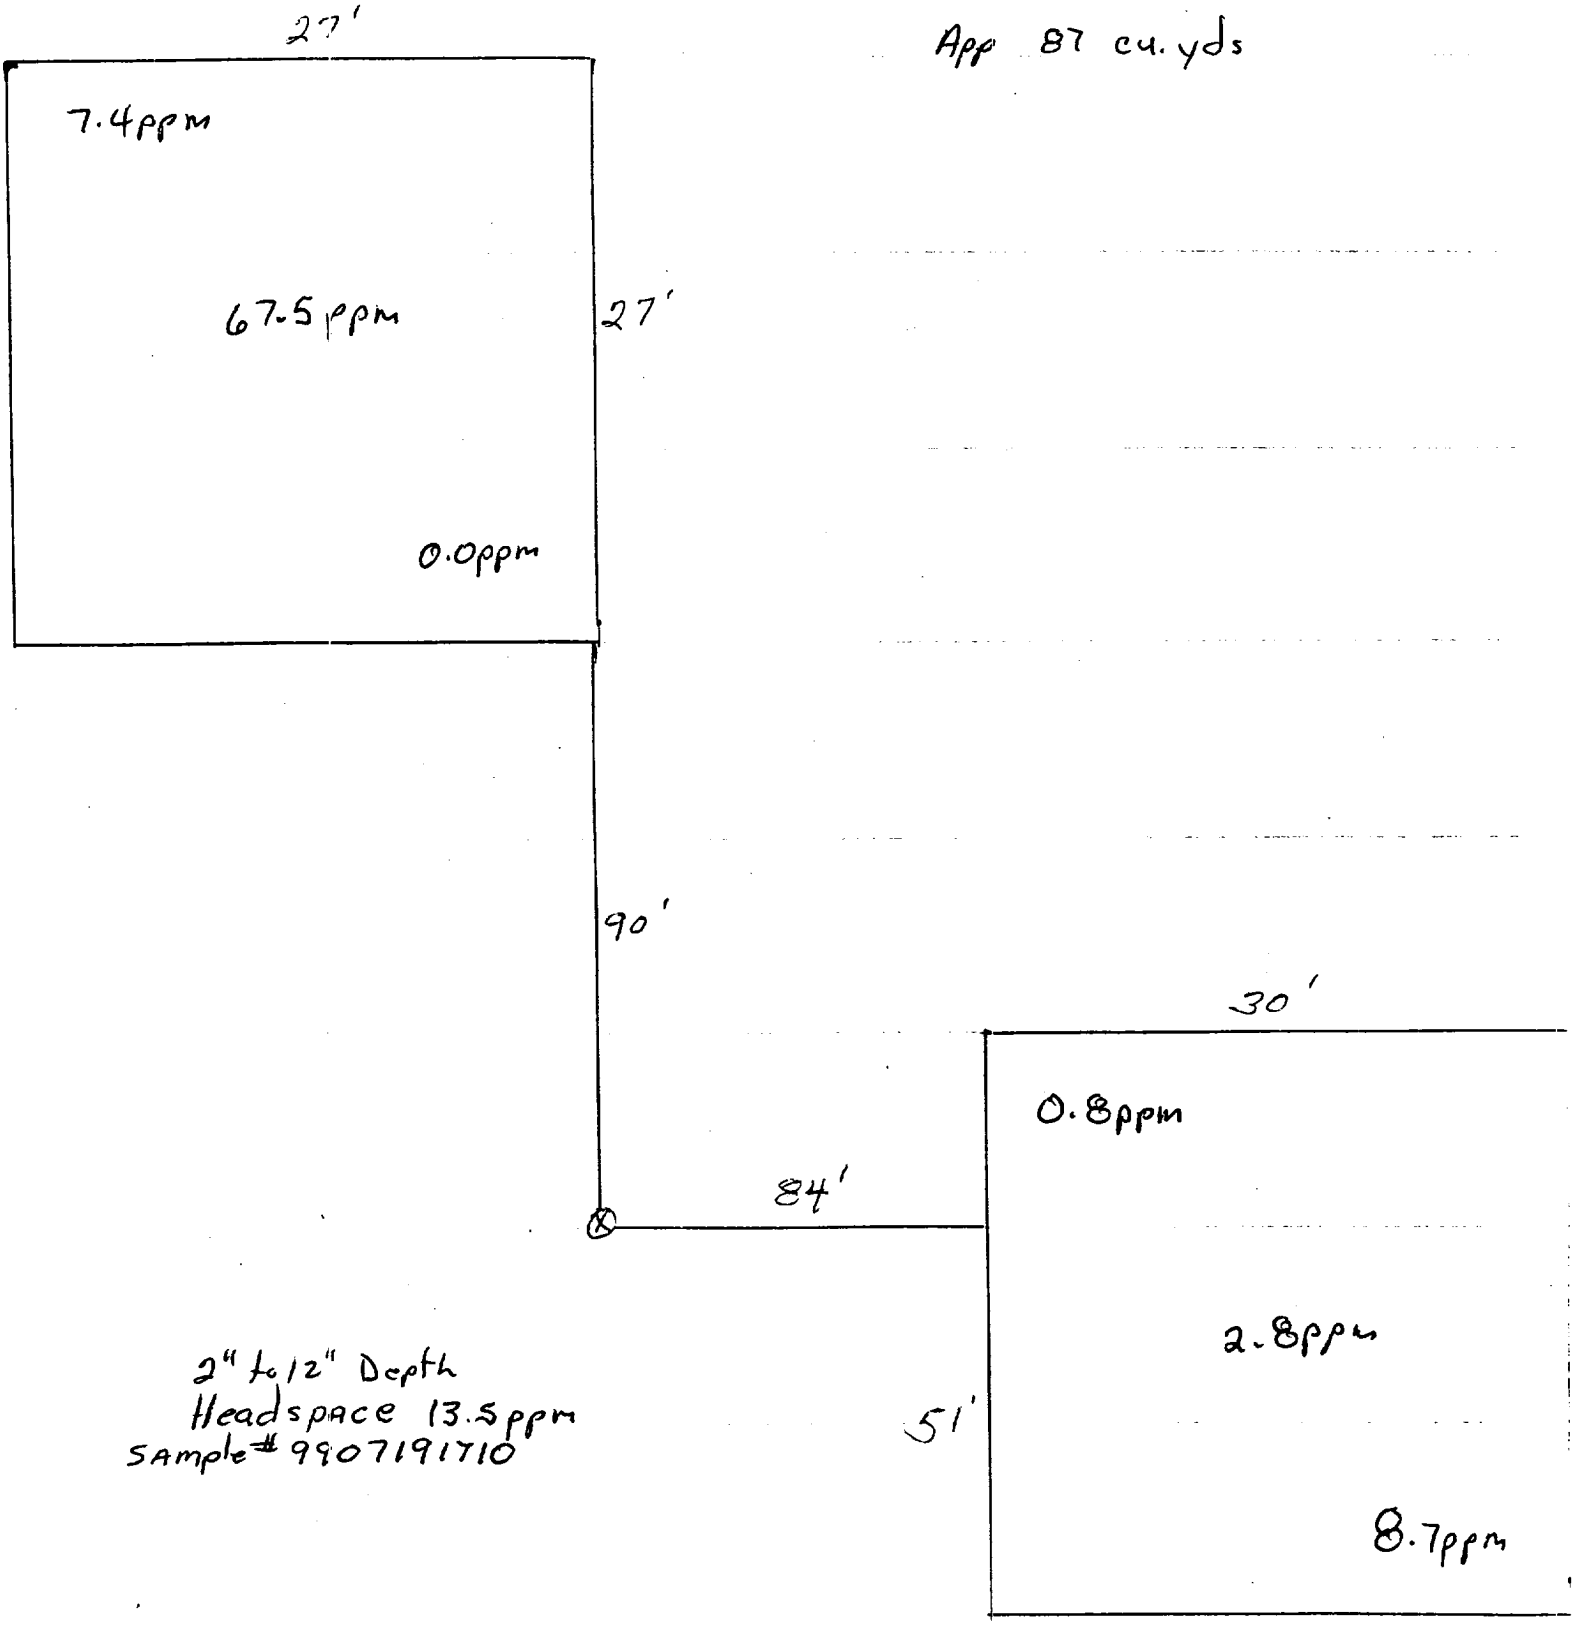
LANDFARM DRAWING

App 87 cu. yds

2" to 12" Depth
Headspace 13.5ppm
Sample # 9907191710
