EL PASO FIELD SERVICES
PRODUCTION PIT CLOSURE

SANCHEZ #3
Meter/Line ID - 73818

FIELD PIT SITE ASSESSMENT FORM

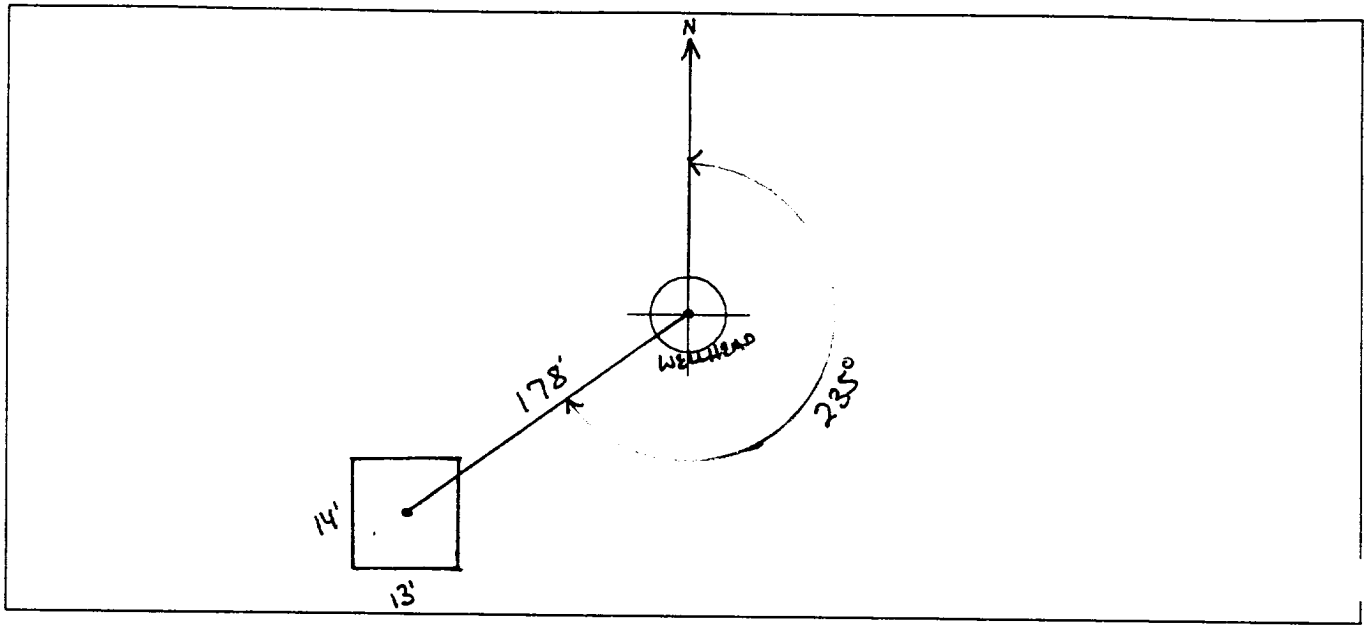
ORIGINAL PIT LOCATION

Remarks : ONLY PIT ON LOCATION. PIT IS DRY. REDLINE AND TOPO CONFIRMED LOCATION TO BE INSIDE THE V.Z.

Original Pit : a) Degrees from North 235° Footage from Wellhead 178'

b) Length : 14' Width : 13' Depth : 1'

DIG & HAUL.
