Meter Number:70065
Location Name:GARTNER A#2 (PIT #1)
Location:TN-30 RG-08
SC-28 UL-G
2 - Federal
NMOCD Zone:OUTSIDE
Hazard Ranking Score:00

RATIONALE FOR RISK-BASED CLOSURE OF PRODUCTION PITS LOCATED OUTSIDE OF THE VULNERABLE ZONE IN THE SAN JUAN BASIN

FIELD PIT SITE ASSESSMENT FORM

FIELD PIT REMEDIATION/CLOSURE FORM

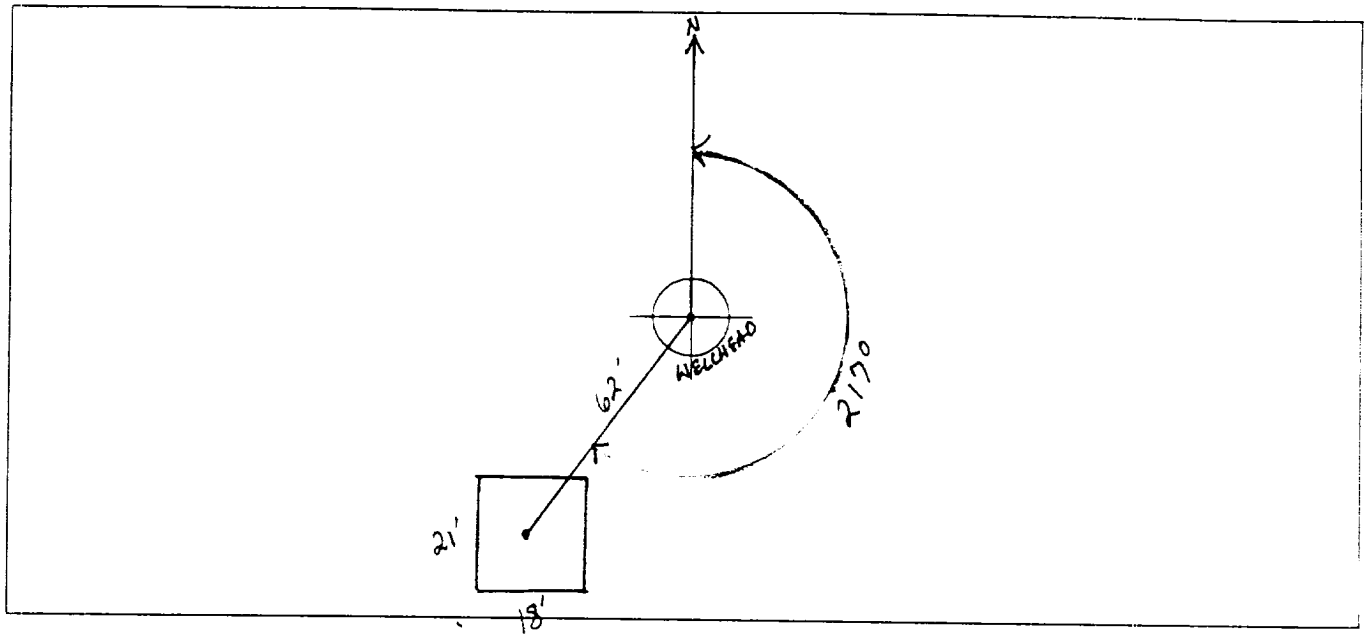
ORIGINAL PIT LOCATION

Remarks : THREE PITS ON LOCATION. WILL CLOSE TWO OF THEM. PITS ARE DRY. LOCATION IS UP ON TOP OF A MESA. REDLINE AND TOPO CONFIRMED LOCATION TO BE OUTSIDE THE V.2.

Original Pit : a) Degrees from North 217° Footage from Wellhead 62'

b) Length : 21' Width : 18' Depth : 2'
