RATIONALE FOR RISK-BASED CLOSURE OF PRODUCTION PITS LOCATED OUTSIDE OF THE VULNERABLE ZONE IN THE SAN JUAN BASIN

FIELD PIT SITE ASSESSMENT FORM

Meter: 73815 Location: J.S. HARTMAN A #1

FIELD PIT REMEDIATION/CLOSURE FORM

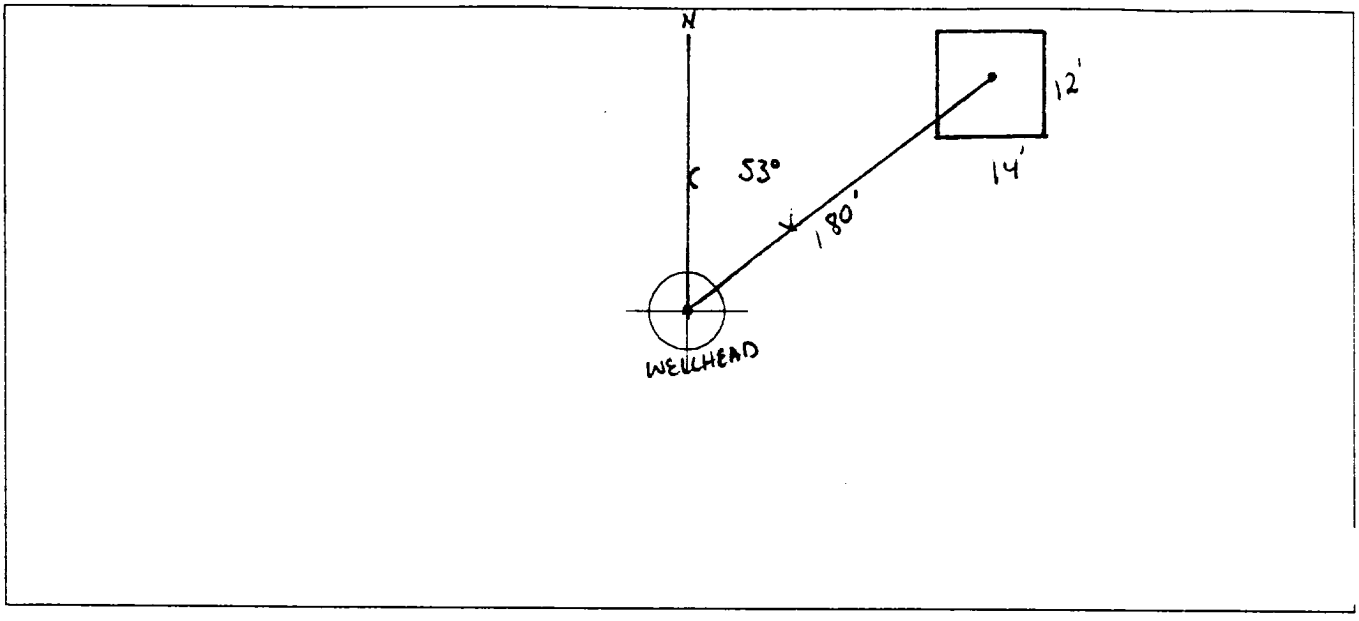
ORIGINAL PIT LOCATION

Original Pit : a) Degrees from North 53° Footage to Wellhead 180'

c) Length : 14' Width : 12' Depth : 2'
