Meter Number:72128
Location Name:BLANCO #10
Location:TN-31 RG-08
SC-26 UL-M
2 - Federal
NMOCD Zone:OUTSIDE
Hazard Ranking Score:00

RATIONALE FOR RISK-BASED CLOSURE OF PRODUCTION PITS LOCATED OUTSIDE OF THE VULNERABLE ZONE IN THE SAN JUAN BASIN

FIELD PIT SITE ASSESSMENT FORM

FIELD PIT REMEDIATION/CLOSURE FORM

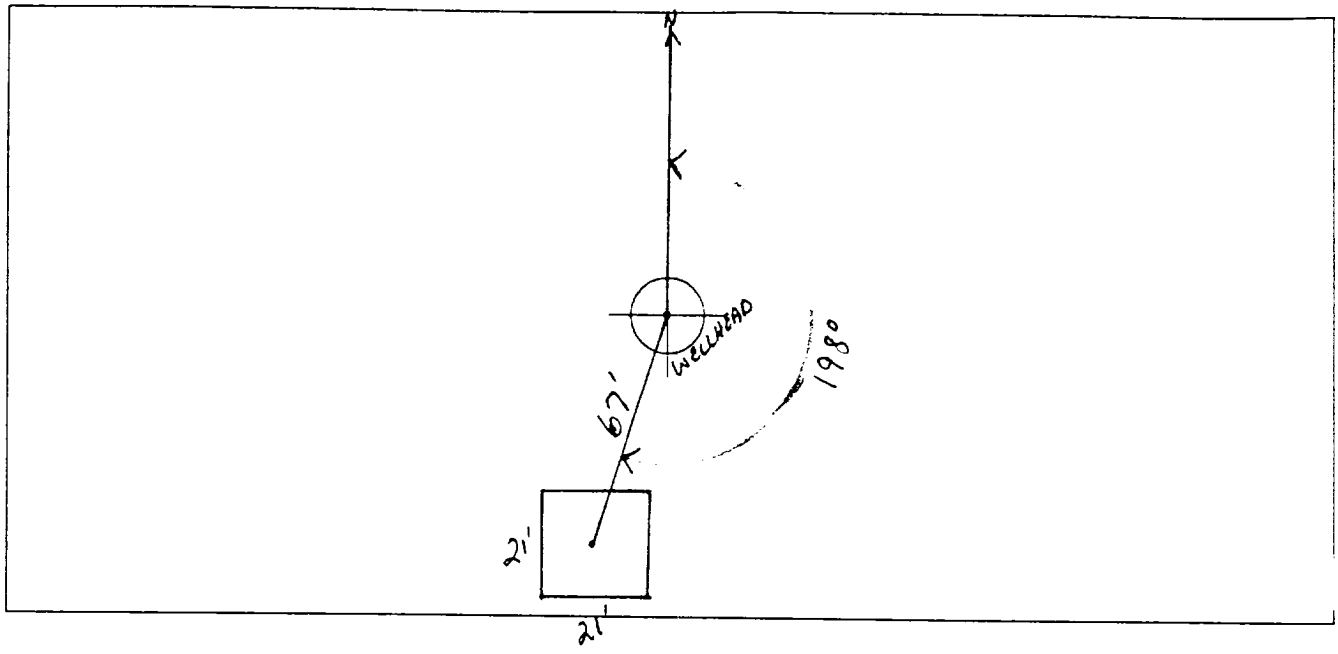
Remarks : ONLY PIT ON LOCATION. PIT IS DRY LOCATION IS ON TOP OF A MESA. REDLINE AND TOPO CONFIRMED LOCATION TO BE OUTSIDE THE V.Z.

Original Pit : a) Degrees from North 198° Footage from Wellhead 62'

b) Length : 21' Width : 21' Depth : 3'
