Meter Number:72378
Location Name:SAN JUAN 32-8 UNIT #8-22
Location:TN-31 RG-08
SC-22 UL-H
2 - Federal
NMOCD Zone:OUTSIDE
Hazard Ranking Score:00

RATIONALE FOR RISK-BASED CLOSURE OF PRODUCTION PITS LOCATED OUTSIDE OF THE VULNERABLE ZONE IN THE SAN JUAN BASIN

FIELD PIT SITE ASSESSMENT FORM

FIELD PIT REMEDIATION/CLOSURE FORM

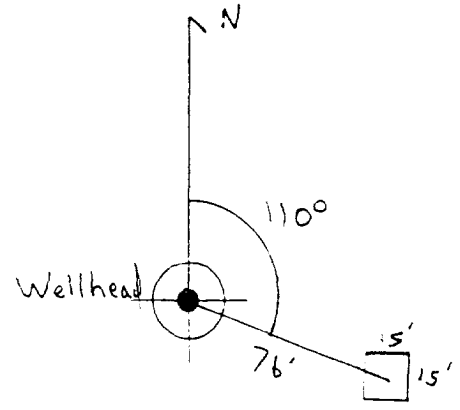
ORIGINAL PIT LOCATION

Original Pit : a) Degrees from North 110° Footage from Wellhead 76'

b) Length : 15' Width : 15' Depth : 4'
