RATIONALE FOR RISK-BASED CLOSURE OF PRODUCTION PITS LOCATED OUTSIDE OF THE VULNERABLE ZONE IN THE SAN JUAN BASIN

FIELD PIT SITE ASSESSMENT FORM

Meter: 71949 Location: SAN JUAN 32-8 #23
Operator #: 7035 Operator Name: PHILLIPS P/L District: BLOOMFIELD
Coordinates: Letter: N Section 14 Township: 31 Range: 8
Or Latitude _____ Longitude _____
Pit Type: Dehydrator ___ Location Drip: X Line Drip: ___ Other: _____
Site Assessment Date: 8.9.95 Area: 10 Run: 11

FIELD PIT REMEDIATION/CLOSURE FORM

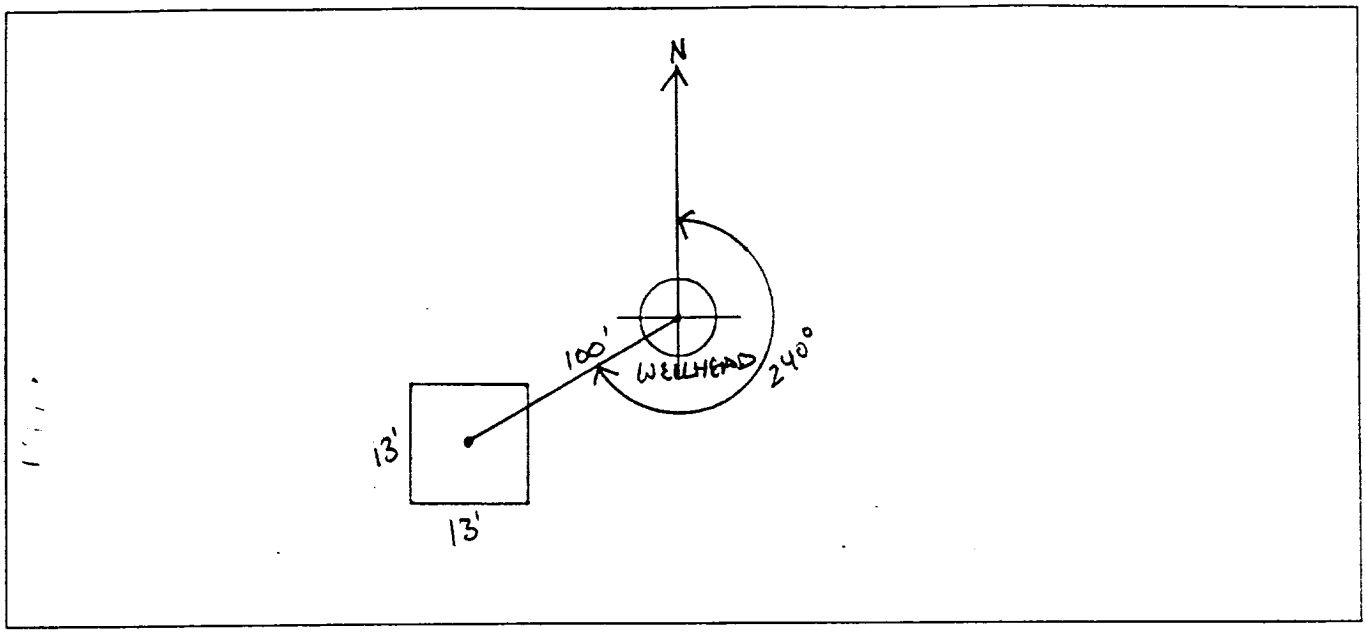
Remarks : REDLINE & TOPO SHOW LOCATION OUTSIDE V.Z. THERE ARE TWO PITS ON LOCATION. LOCATION DRIP PIT BELONGS TO EPNG. SEP. PIT BELONGS TO OPERATOR. WILL CLOSE EPNG'S PIT.

Original Pit : a) Degrees from North 240° Footage from Wellhead 100'

b) Length : 13' Width : 13' Depth : 2'
