PIT REMEDIATION AND CLOSURE REPORT

Facility Or: Well Name FLORANCE # 58

FIELD REPORT: CLOSURE VERIFICATION

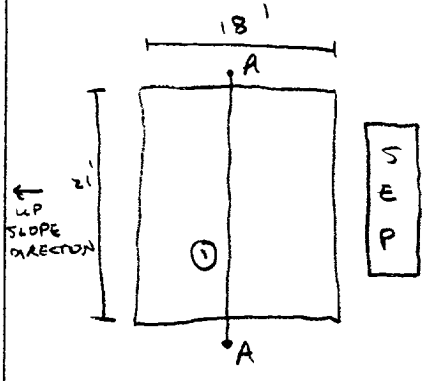
PIT PERIMETER

EXCAVATION CONSIST OF MOSTLY BEDROCK (SANDSTONE) COLOR VARYING FROM PALE ORANGE TO DK. GRAY (OVM SAMPLE) VERY HARD @ PIT BOTTOM, 6" STAINING OBSERVED WITHIN SANDSTONE ON WEST SIDEWALL @ APPROX. 3 FT. BELOW GRADE, OVM SAMPLE FROM BEDROCK, THEREFORE NO TPH ANALYSIS WAS CONDUCTED.

SAMPLE ID	FIELD HEADSPACE PID (ppm)
1 @ 5'	141
2 @	
3 @	
4 @	
5 @

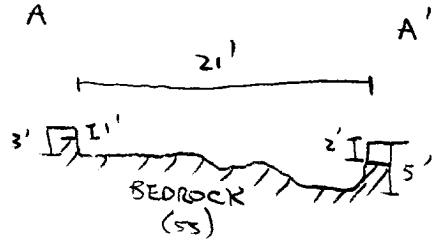
PIT PROFILE

MOSTLY BEDROCK (SS)
