RATIONALE FOR RISK-BASED CLOSURE OF PRODUCTION PITS LOCATED OUTSIDE OF THE VULNERABLE ZONE IN THE SAN JUAN BASIN

FIELD PIT SITE ASSESSMENT FORM

Meter: 75792 Location: STATE COM LL #12

FIELD PIT REMEDIATION/CLOSURE FORM

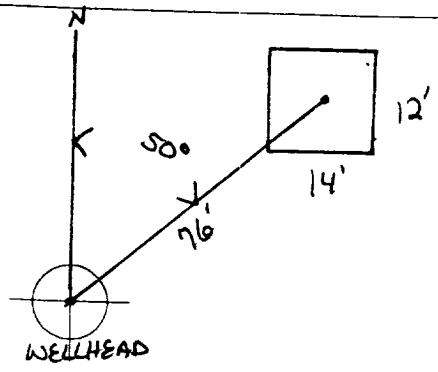
ORIGINAL PIT LOCATION

Original Pit : a) Degrees from North 50° Footage to Wellhead 76'

c) Length : 14' Width : 12' Depth : 2'
