Meter Number:75793
Location Name:STATE COM LL #13
Location:TN-30 RG-09
SC-32 UL-L
2 - Federal
NMOCD Zone:OUTSIDE
Hazard Ranking Score:00

RATIONALE FOR RISK-BASED CLOSURE OF PRODUCTION PITS LOCATED OUTSIDE OF THE VULNERABLE ZONE IN THE SAN JUAN BASIN

FIELD PIT SITE ASSESSMENT FORM

FIEL PIT REMEDIATION/CLOSU FORM

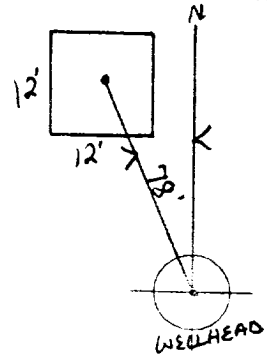
ORIGINAL PIT LOCATION

Remarks : ONLY PIT ON LOCATION. PIT IS DRY.

Original Pit : a) Degrees from North 337° Footage to Wellhead 78'

c) Length : 12' Width : 12' Depth : 1'
