Meter Number:75881
Location Name:FLORANCE 101
Location:TN-30 RG-08
SC-29 UL-O
2 - Federal
NMOCD Zone:OUTSIDE
Hazard Ranking Score:00

RATIONALE FOR RISK-BASED CLOSURE OF PRODUCTION PITS LOCATED OUTSIDE OF THE VULNERABLE ZONE IN THE SAN JUAN BASIN

FIELD PIT SITE ASSESSMENT FORM

FIELD PIT REMEDIATION/CLOSURE FORM

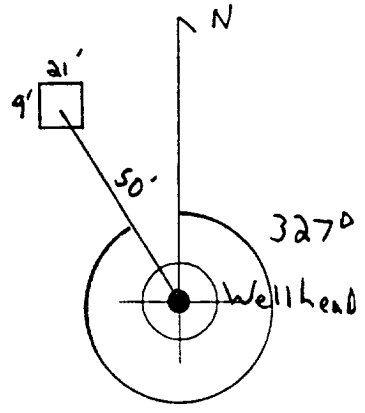
ORIGINAL PIT LOCATION

Remarks : Redline Book: Outside Vulnerable Zone Topo: Outside
2 pits. Will close. Liquid in pit.

Original Pit : a) Degrees from North 327° Footage from Wellhead 50'

b) Length : 21' Width : 9' Depth : 2'
