Meter Number:90814
Location Name:SCHUMACHER COM #1A
Location:TN-30 RG-10
SC-18 UL-D
4 - Fee
NMOCD Zone:OUTSIDE
Hazard Ranking Score:00

RATIONALE FOR RISK-BASED CLOSURE OF PRODUCTION PITS LOCATED OUTSIDE OF THE VULNERABLE ZONE IN THE SAN JUAN BASIN

FIELD PIT SITE ASSESSMENT FORM

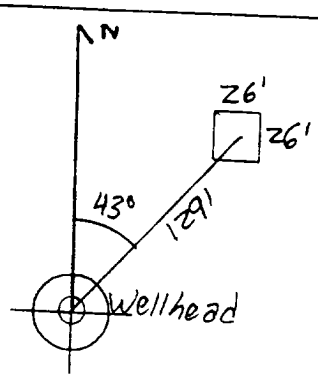
ORIGINAL PIT LOCATION

Original Pit : a) Degrees from North 43° Footage from Wellhead 129'

b) Length : 26' Width : 26' Depth : 3'
