PIT REMEDIATION AND CLOSURE REPORT

Facility Or: Well Name Giomi com A #1R

FIELD REPORT: CLOSURE VERIFICATION

LOCATION: NAME: GUMM COM A WELL #: 1R PIT: ABAN. SEP.

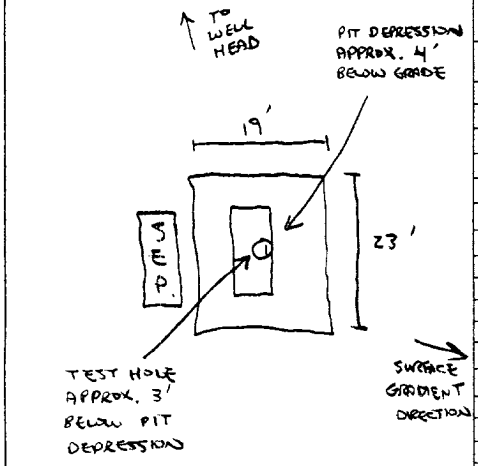
PIT PERIMETER

BEDROCK (SANDSTONE) EXPOSED @ 5'-7' BELOW GRADE WITHIN TEST HOLE, OR DUE TO MED. GRAY IN COLOR SLIGHTLY FRIABLE TO VERY HARD @ BOTTOM, STRONG HC ODOR DETECTED ONLY WITHIN DISCOLORED BEDROCK, SAMPLE COLLECTED FROM BEDROCK, THEREFORE NO TPH ANALYSIS WAS CONDUCTED.

RISK ASSESSED

BEDROCK BOTTOM
