Meter Number:72381
Location Name:E.E. ELLIOT B#4
Location:TN-30 RG-09
SC-27 UL-P
2 - Federal
NMOCD Zone:OUTSIDE
Hazard Ranking Score:00

RATIONALE FOR RISK-BASED CLOSURE OF PRODUCTION PITS LOCATED OUTSIDE OF THE VULNERABLE ZONE IN THE SAN JUAN BASIN

FIELD PIT SITE ASSESSMENT FORM

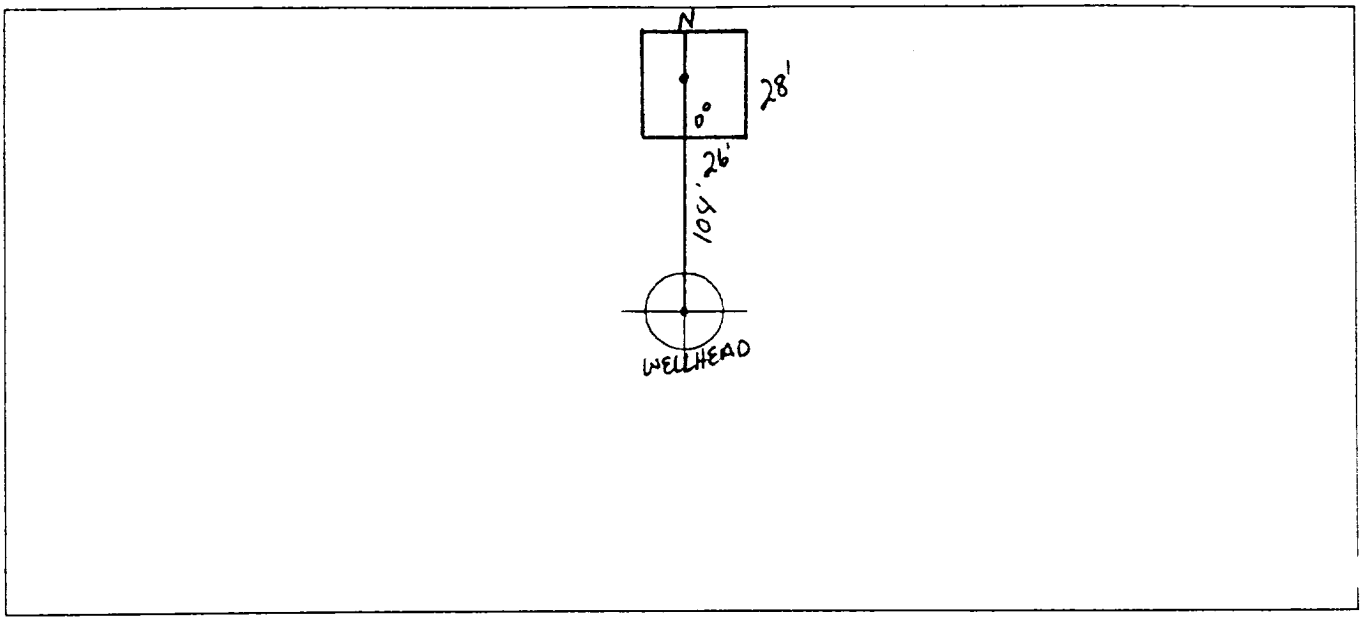
ORIGINAL PIT LOCATION

Remarks : ONLY PIT ON LOCATION. PIT IS OILY LOCATION IS UP ON A MESA.

Original Pit : a) Degrees from North 0° Footage from Wellhead 104'

b) Length : 28' Width : 26' Depth : 2'
