Re: Lovington Paddock Unit 89 Well Pad Abandonment Assessment Report

Soil Assessment and Delineation Activities Report

Lovington Paddock Unit No. 89 Well-Site
Unit E, Section 31, Township 16 South, Range 37 East
Lovington, New Mexico

074287 | Report No 3 | October 16, 2015

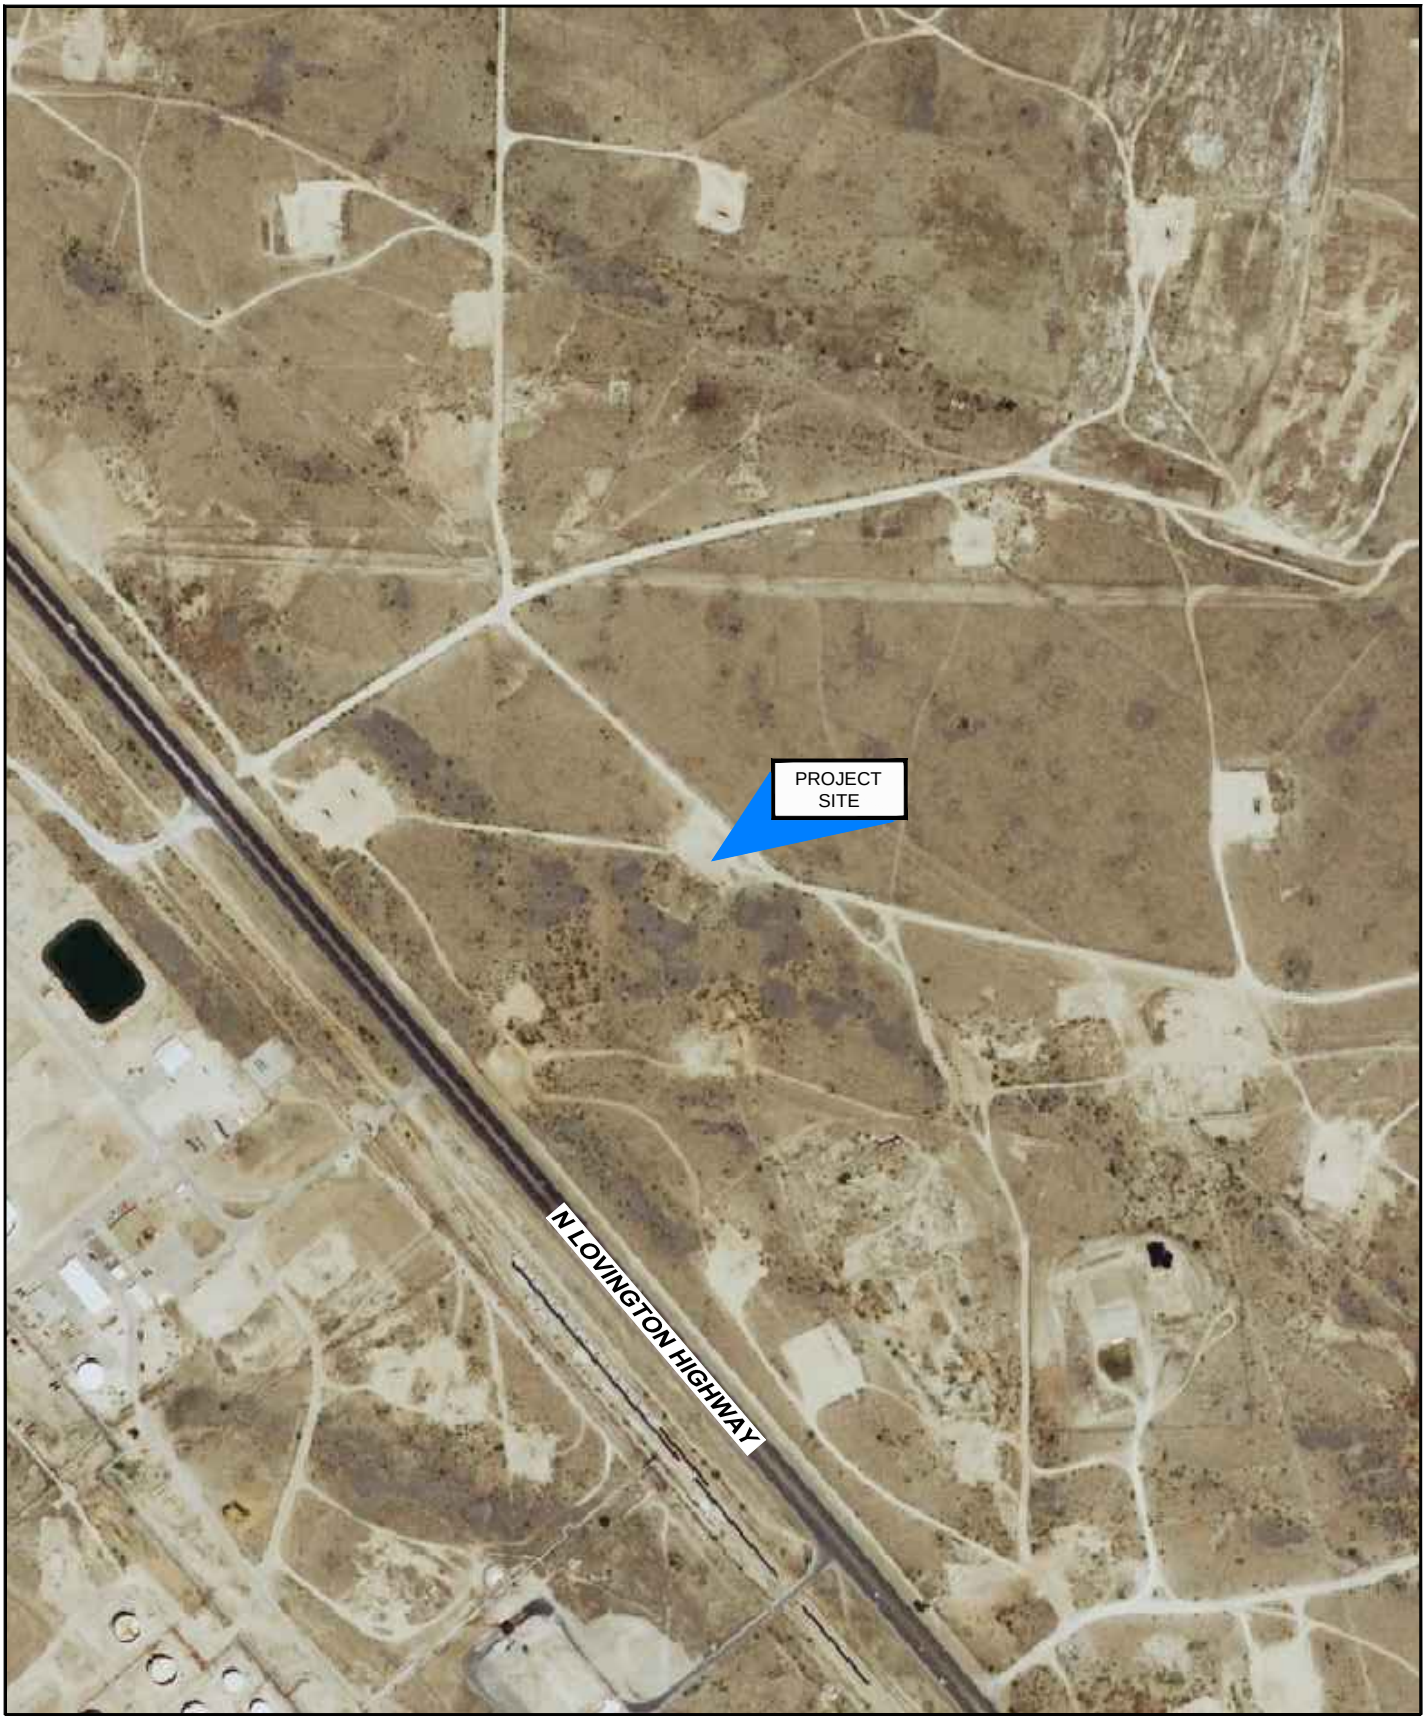
FIGURE 1

SITE LOCATION MAP
